REPORT#: 15NY032

REPORT DATE: 04/19/22

Construction Worker Fatally Struck by Steel Sheet Pile Falling from a Vibratory Pile Driver

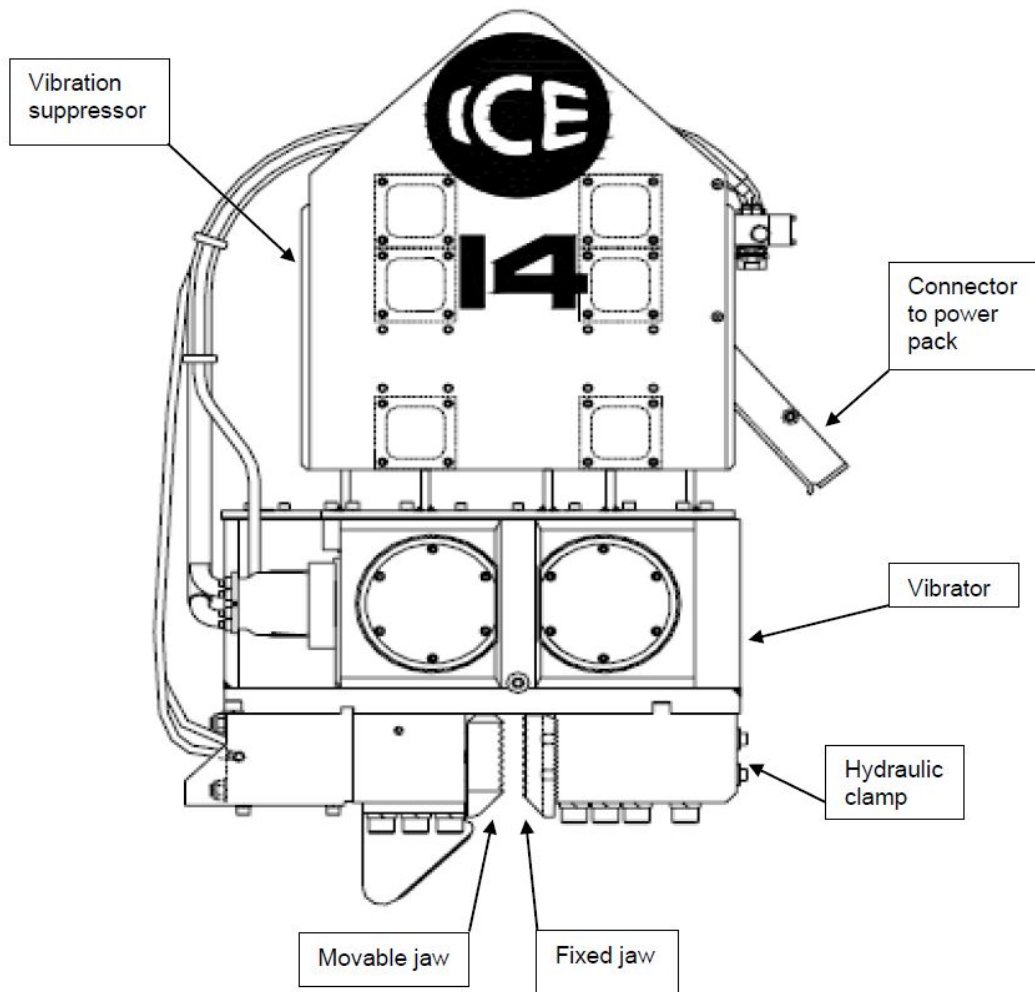
Figure 1. Major components of ICE 14-23 vibratory pile driver/extractor.

The pile driver consisted of three major components: The vibrator, the vibration suppressor, and the hydraulic clamp (Figure 1 and Photo 1). Vibration was created in the vibrator gear case by a pair of rotating eccentric weights powered by hydraulic motors. Only vertical vibration was created as horizontal vibration being canceled by the paired eccentrics. The vertical vibration was transmitted into the pile being driven by the hydraulic clamp which was attached to the bottom of the gear case. The pile driver was held by a crane during pile driving. To prevent the vibration created in the gear case from affecting the crane, a vibration suppressor absorbed and dampened the vibrations reaching the crane.

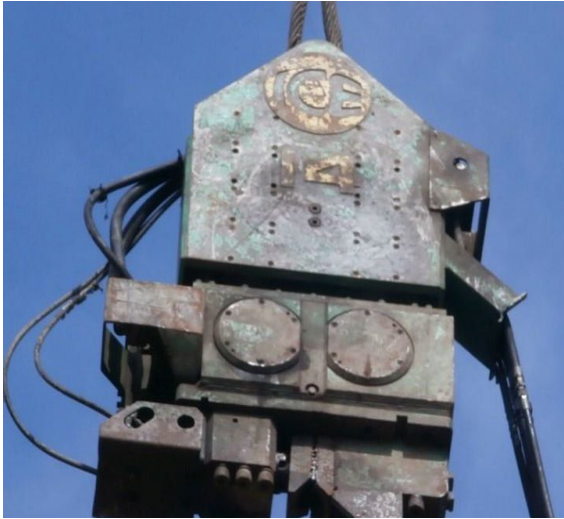
Photo 1. The International Construction Equipment, Inc (ICE) Model 14-23 vibratory driver/extractor that was involved in the incident (photo courtesy of OSHA).

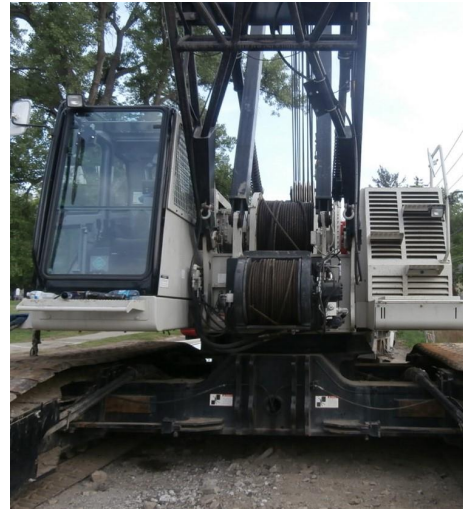
Photo 2. The Link-Belt crane had two winding drums, one for the main hoist rope and the other for the auxiliary hoist rope (photo courtesy of OSHA).

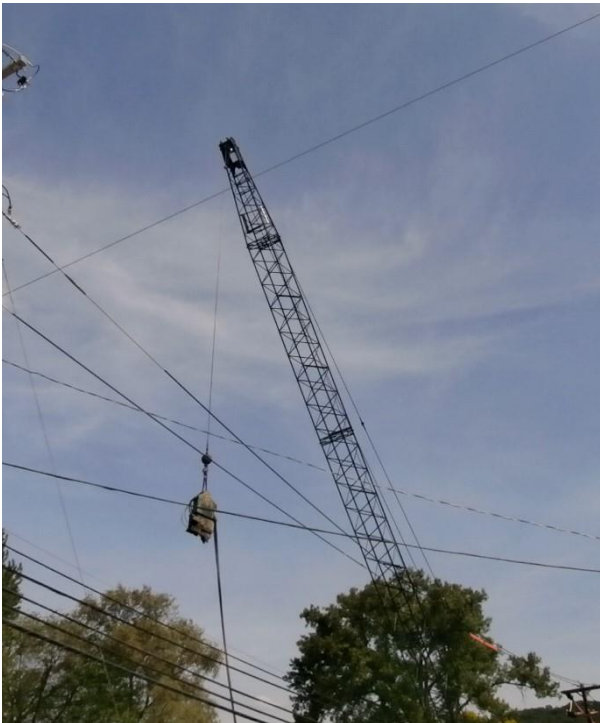
Photo 3. The crane had only one load line that was holding the pile driver. The auxiliary hoist was never rigged (photo courtesy of OSHA).

For a typical pile driving operation, at least two crane hoist lines are needed: The main hoist line to hold the pile driver and the auxiliary line to hold the pile. In addition, the pile must be rigged to the auxiliary hoist through a safety line. The Link-Belt crane had two winding drums, one for the main hoist rope and the other for the auxiliary hoist rope (Photo 2). However, the crew only rigged the main hoist on Thursday. The auxiliary hoist was never rigged (Photo 3).

Recommendation #1: Employers should ensure that piles are always secured to the crane via a safety line for as long as the piles are being held by the crane.

The crew in this case never rigged the crane's auxiliary hoist which should have been used to hoist and secure the sheet pile through a safety line. Employers should ensure that the pile driving crew and the crane operators strictly follow the manufacturer's safety requirement.

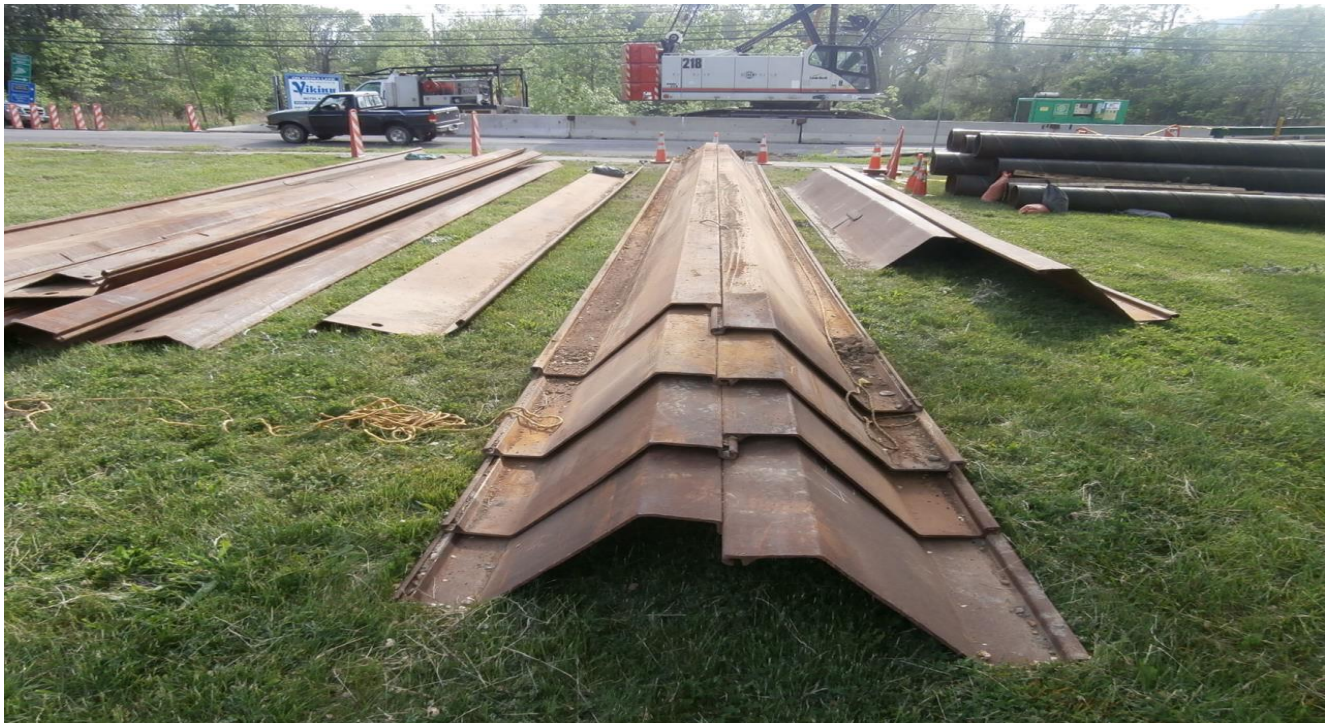
Photo 4. Two piles were interlocked to form a “pair” or “double sheet”. The double-sheet pile were approximately 40 feet long and 4000 pounds in weight (photo courtesy of OSHA).

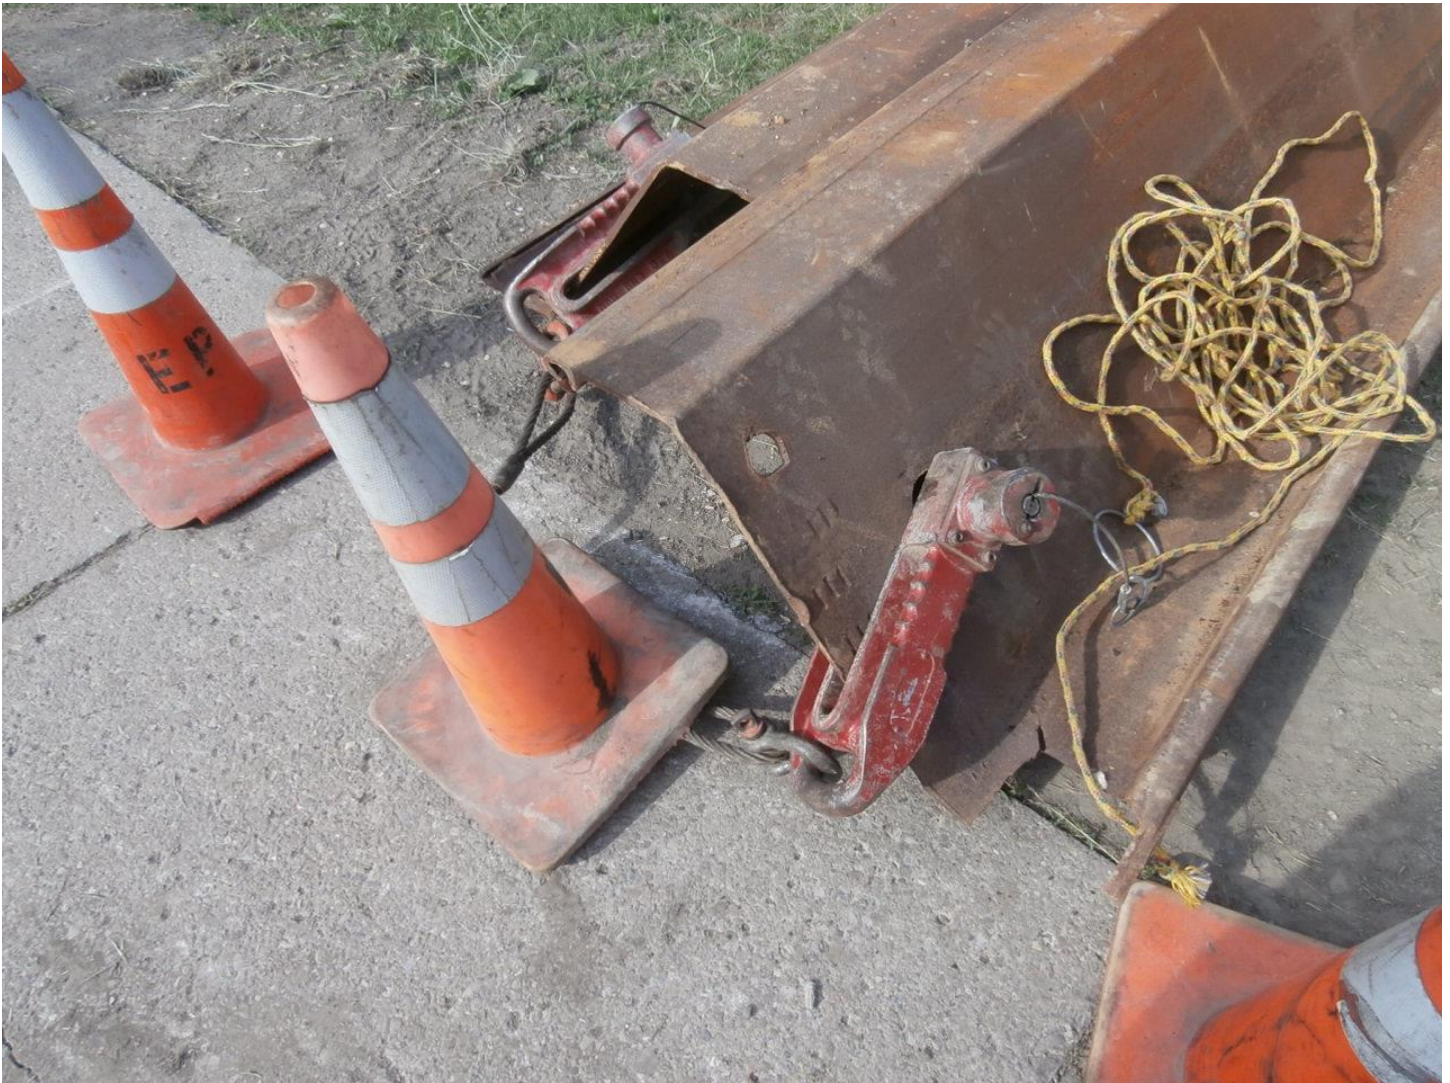
At the staging area, the crew attached a pair of sheet pile shackles to a double-sheet pile (Photo 5). The shackles had a ground release mechanism with a release line, which could be used to remove the shackles from the sheet pile from the ground. The crane picked up the sheet pile by the pile shackle wire with the pile driver's hydraulic clamp and placed it in driving position. Once in position, the shackles were removed from the pile. With the help of an excavator, the foreman used a level to make sure that the sheet pile was plumb and aligned. The pile driver then was aligned, and the hydraulic clamp was set in the "close" position, grabbing the pile. The sheet pile from then on was only held by the hydraulic clamp, and there was no safety line to secure the sheet pile to the crane. At approximately 10:30 a.m., the foreman turned the power on at the power pack and started pile driving. The superintendent left to visit the other job site before pile driving started.

Photo 5. Pile shackles with ground release attached to a pair of sheet pile (photo courtesy of OSHA).

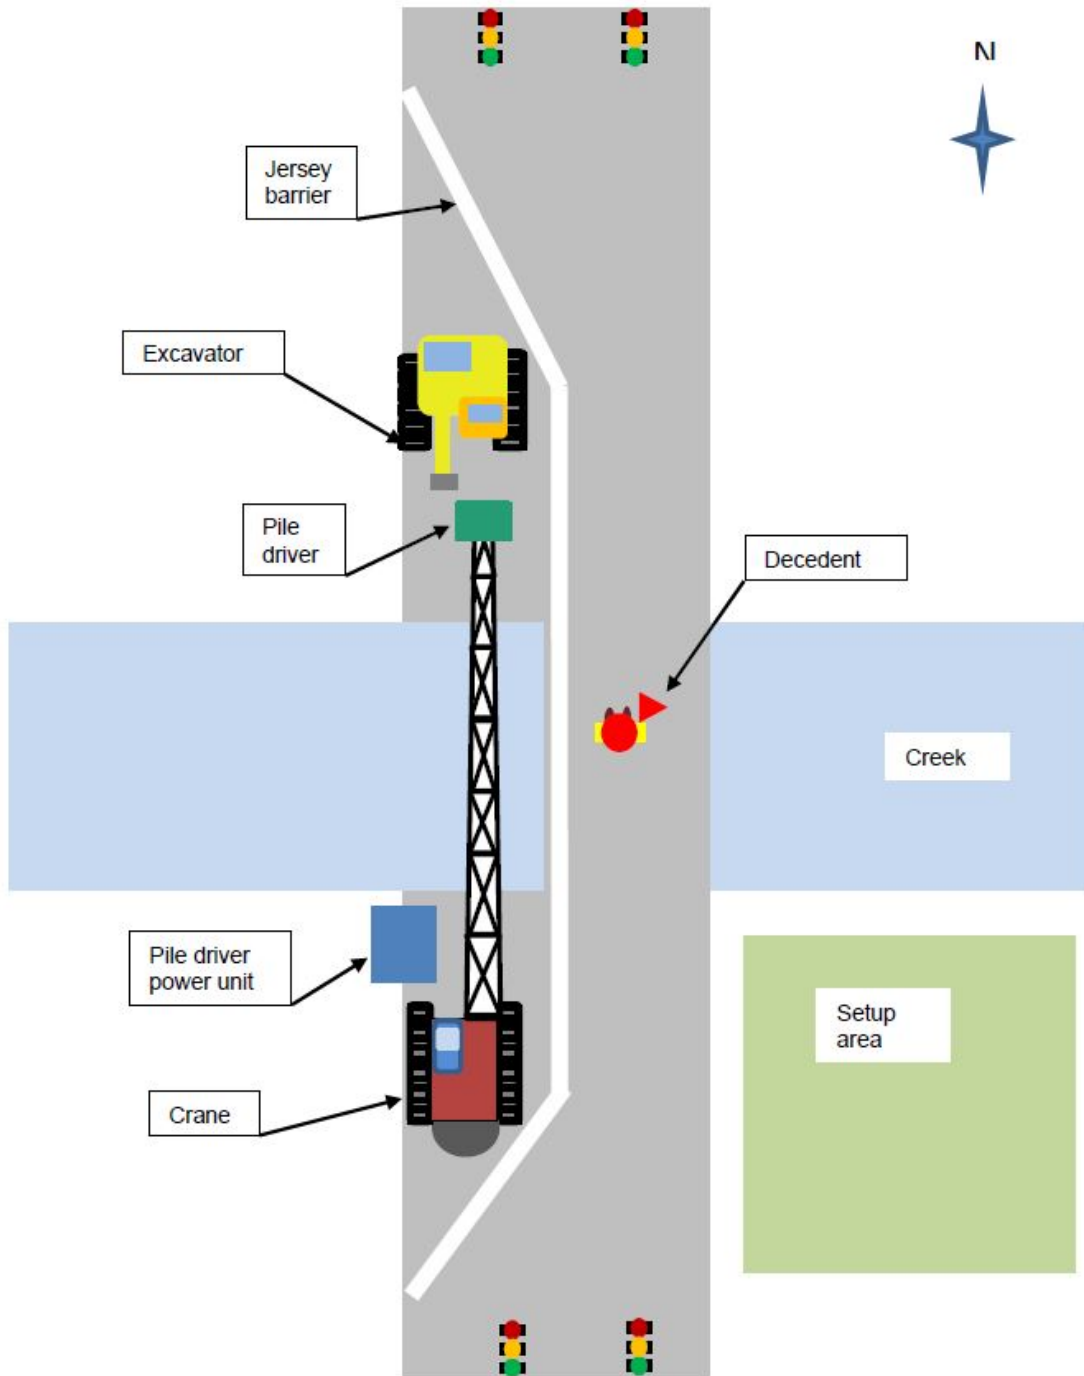
Figure 2. Incident site sketch showing locations of the decedent and the pile driving operation.

At approximately 11:00 a.m. the traffic lights at both ends malfunctioned. Instead of alternating in red or green cycles, both lights went to flashing yellow simultaneously. The decedent was first directing the traffic at the north end of the bridge. Once the traffic lights malfunctioned, the traffic kept encroaching into the work zone. The foreman sent the decedent to the center of the bridge so that she could better control the traffic (Figure 2. Incident site sketch).

Recommendation #2: Employers should ensure that all workers are protected from being struck by the load of the crane during pile driving.

When replacing infrastructure, one major challenge is the tight work zones. The crane swing radius in this case extended beyond the actual width of the bridge. The decedent who was directing traffic in the middle of the bridge was exposed to the fatal struck-by hazard. Employers should consider using two flaggers, one at each end of the construction zone, to ensure that flaggers can work safely outside the fall zone.

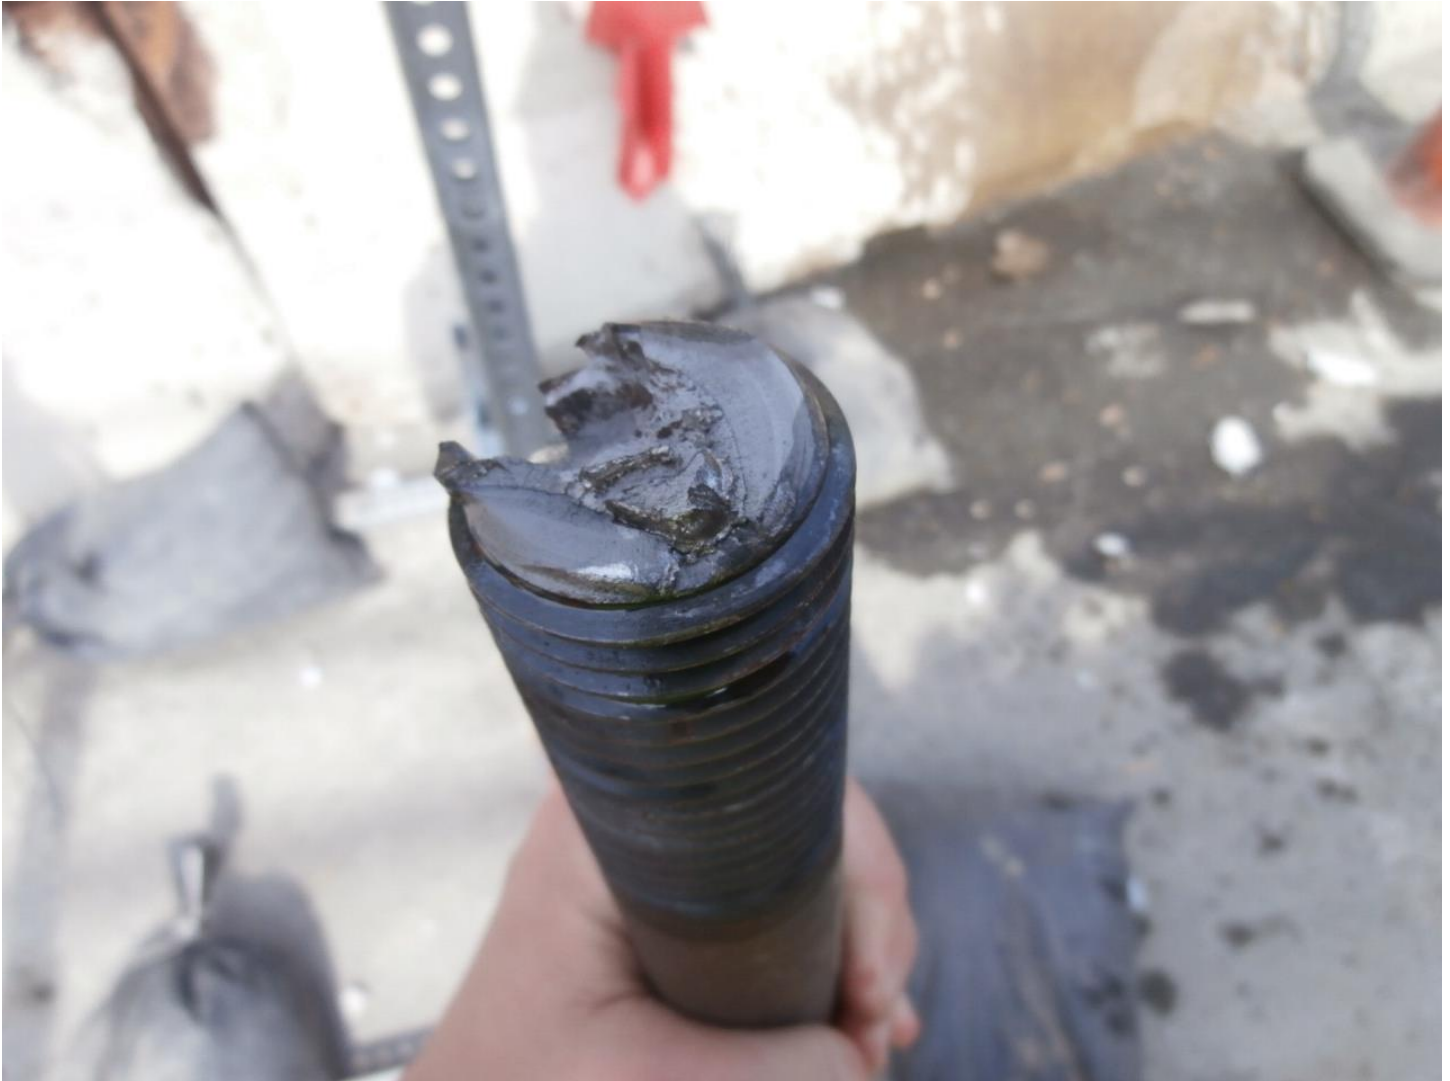
Two broken bolts were found at the site after the incident. Each bolt had metal failures, leaving a portion of the threaded end in the pile driver (Photo 6). One bolt piece was found on the north side of the bridge, this was the one observed by the crew. The other piece was found on the south side of the bridge, on the debris netting. Both pieces were 1 ¹/₂ inches in diameter, and one was 11 ⁵/₈ inches long, and the other was 12 ¹/₈ inches long. They were the clamp bolts that secured the fixed jaw to the gear case.

Photo 6. The clamp bolt broken from the vibratory pile driver had metal failure (photo courtesy of OSHA).

Recommendation #3: Employers should ensure that the hydraulic clamp bolts are inspected and evenly tightened to appropriate torque as specified by the manufacturer.

The manufacturer in this case required that the clamp bolts be torqued to 2800 ft-lbs (3.79 kN-m) with a torque wrench. The crew did not have a torque wrench on site, and the foreman did not know the correct torque. Employers should ensure that all clamp bolts are evenly tightened to the specified torque, and all clamp bolts are inspected at the beginning of each shift. Since vibration loosens bolts, workers should check the bolts periodically during their shifts depending on driving conditions. If one bolt breaks, all bolts must be immediately replaced since others may be damaged. Never drive piles if one or more bolts are broken.

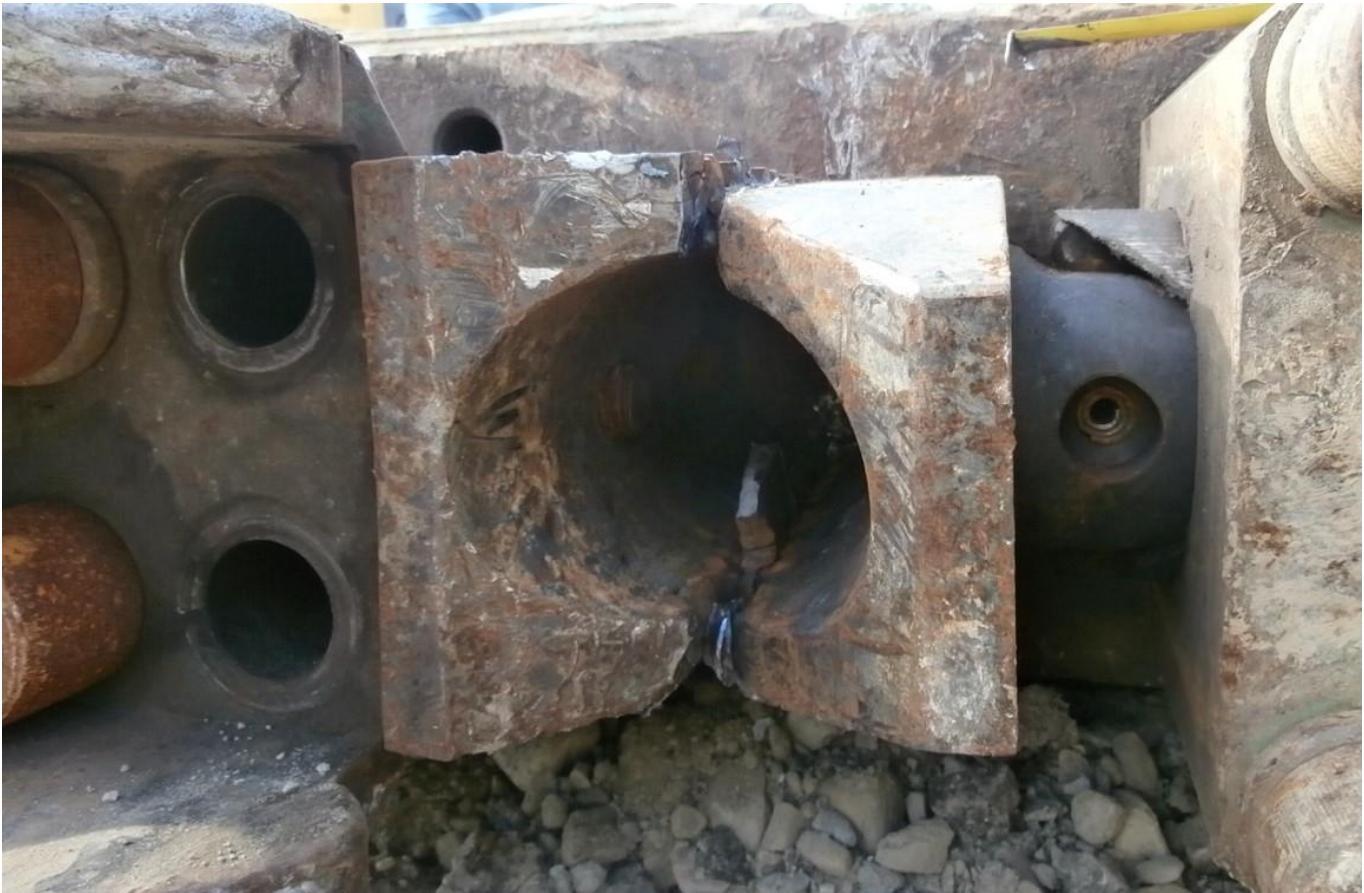
Both fixed and movable jaws had two clamp areas with teeth: Each clamp area was approximately 1 inch wide and 7 ³/₄ inches long with 10 teeth (Photos 7 and 8). All four clamping surfaces had worn or broken teeth: The peaks were either broken off or worn flat. The sections that had worn or broken peaks were approximately 4 inches long from the end of the jaws where they gripped the piles. The jaws were mis-aligned in all three dimensions resulting in unparallel gripping surfaces and mis-aligned and partially engaged teeth.

Photo 7. The bolt holes of the broken bolts and clamp areas of fixed and movable jaws of the hydraulic clamp. Both the fixed and movable jaws have two clamp areas with teeth. The jaws were mis-aligned (photo courtesy of OSHA).

Recommendation #4: Employers should ensure that the hydraulic clamp teeth are in good working condition and the fixed and movable jaws are aligned properly.

Employers should ensure that operators inspect the hydraulic clamp teeth and the gripping jaws to ensure that they are properly aligned and in good working condition before starting the pile driver. A jaw with cracked, broken, unevenly worn, or non-engaging teeth should be replaced immediately.

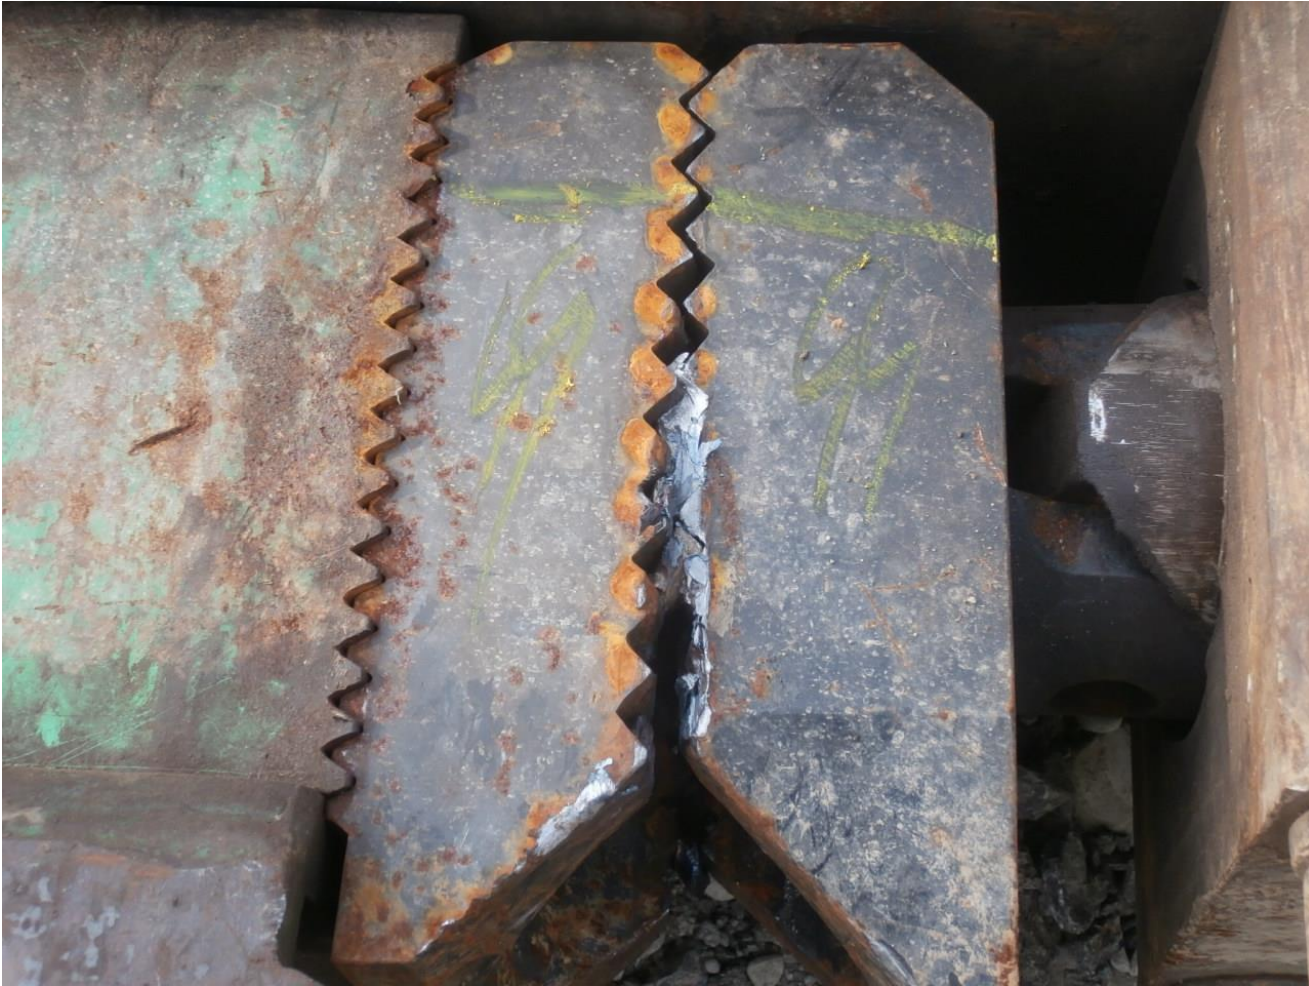
Photo 8: The jaws had worn or broken teeth: the peaks were broken off or worn flat especially in the lower end of the jaws. Part of the sheet pile was still being held by the jaws (photo courtesy of OSHA).

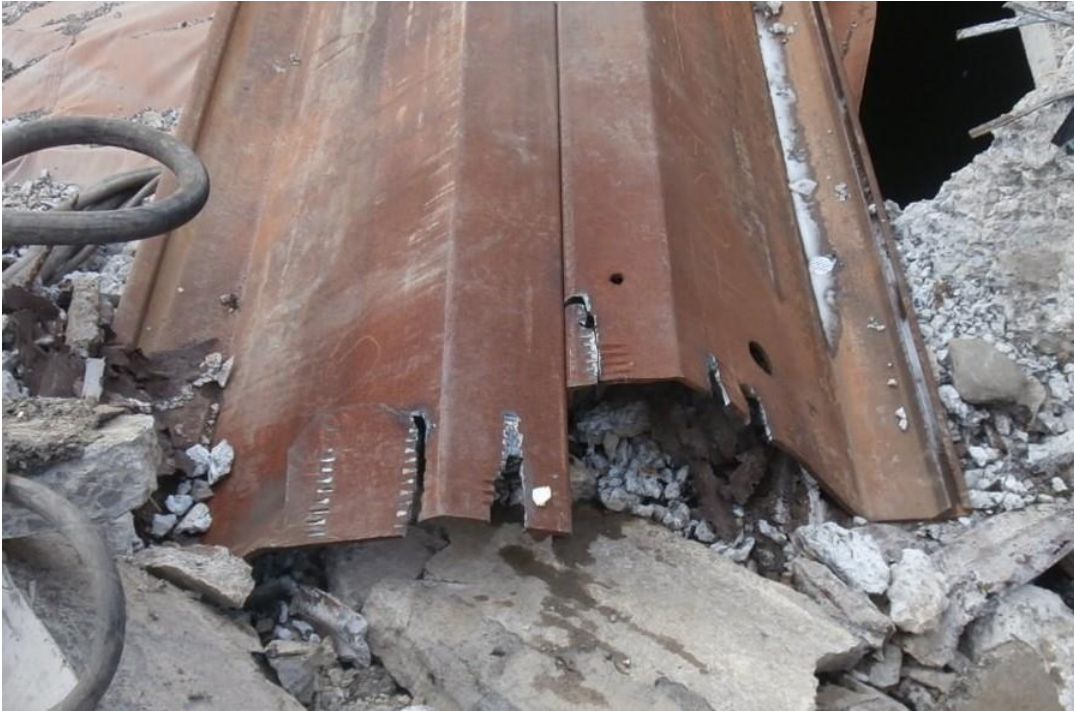
The failures on three clamped areas on the interlocked sheet piles were examined (Photo 9). Each clamped area had two grip marks (left and right). All clamped areas had tooth imprints indicating unevenly worn and partially engaged teeth. For example, the left gripping mark of the first grip showed that the top part of the sheet pile was being crushed and the lower part was ripped or torn off, indicating uneven pressure distribution among gripping teeth.

The post incident analysis determined that the sheet pile fractured and broke at the point where it was being gripped by the hydraulic clamp. The hydraulic clamp did not fail: It was holding the broken sheet pile piece. The root cause of this fatal incident was that the sheet pile was not rigged to the crane, allowing it to fall and strike the decedent. The untightened or unevenly torqued bolts, mis-aligned clamp jaws, and broken or unengaged teeth in the clamp area exposed the pile driver to excessive forces and vibrations and contributed to the failure of the sheet piles and the clamp bolts.

Photo 9. All three gripping areas on the sheet pile had tooth imprints indicating unevenly worn and partially engaged teeth and uneven distribution of pressure (photo courtesy of OSHA).

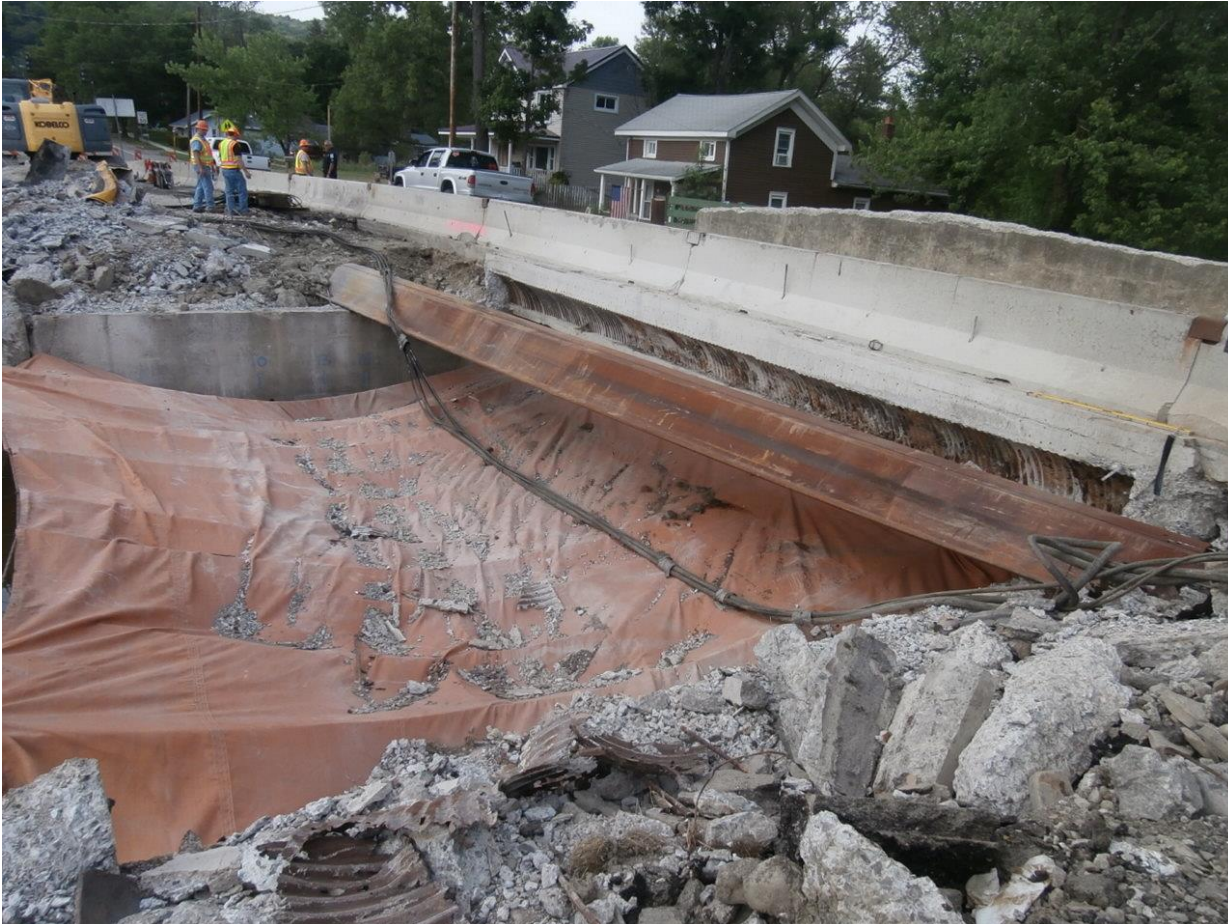
The incident occurred at 12:04 p.m. when the sheet pile was being driven down between 18 and 24 inches below grade. According to the foreman, he observed a large bolt falling off the pile driver and immediately hit the emergency stop. At the same time the sheet pile, which was not secured to the crane, broke from the pile driver and started to topple over. The sheet pile landed on a concrete jersey barrier and started to slide on top of it. The jersey barrier was parallel to the roadway. The sheet pile was sliding horizontally on top of the jersey barrier with its length spanning the width of the bridge. Meanwhile, the decedent was running south from the center of the bridge where she was directing traffic, trying to avoid being struck by the sliding sheet pile. The sheet pile struck the decedent from behind near the south end of the bridge before it slid and fell off the jersey barrier and landed on the west side of the bridge (Photo 10). The victim suffered injuries on the head, neck, and back.

Photo 10. *The sheet pile broke from the pile driver, fell and landed on the west side of the bridge (photo courtesy of OSHA).*
