REPORT#: 17KY007

Dry Wall Supervisor Falls from Unsecured Plank

State **FACE** Program

Fatality Assessment & Control Evaluation

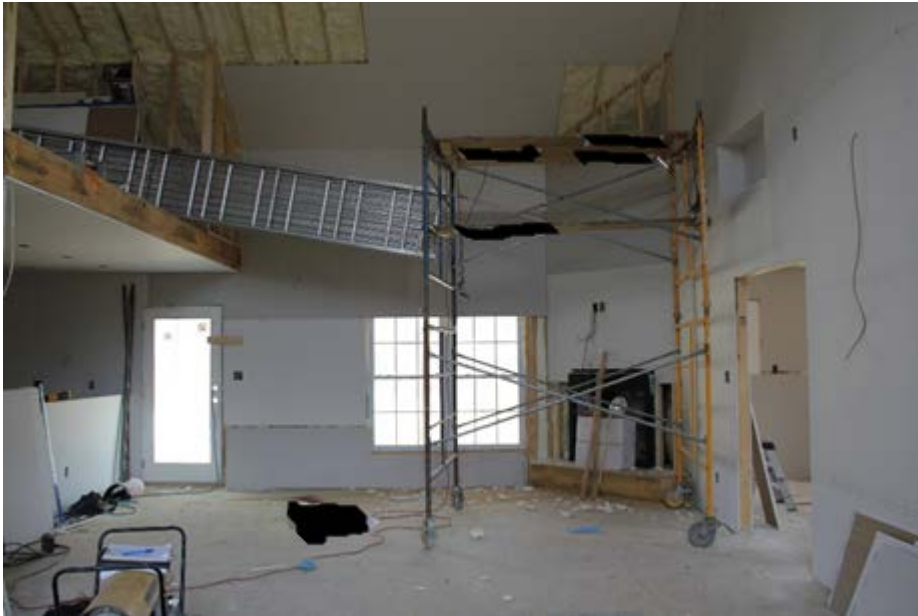
Figure 1. Scaffold and plank from which the victim fell

On Wednesday afternoon, a supervisor (the victim) and another drywall installer arrived at a newly constructed 4,200 square foot home to set up scaffolding in order to hang dry wall. The supervisor was in the process of erecting a mobile scaffold, but had yet to install any guardrails. The scaffold was a 'Bil-Jax' mobile scaffold with locking caster wheels. The victim was on the second buck of the two buck high scaffold. Resting on the seventh of the scaffold's eight bearers - a horizontal transverse scaffold member upon which the scaffold platform rests and which joins scaffold uprights, posts, poles, and similar members - was an aluminum walk plank that allowed access to an open loft area where drywall was stored for easy access. The walk plank was a model #LL0420 manufactured by Green Bull with a maximum weight of 750 lbs. The walk plank, which lacked attaching hooks and was unsecured on both ends, sat 11 feet above the lower level. The scaffold's wheels were locked in place and braced against the wall to prevent it from moving unexpectedly.

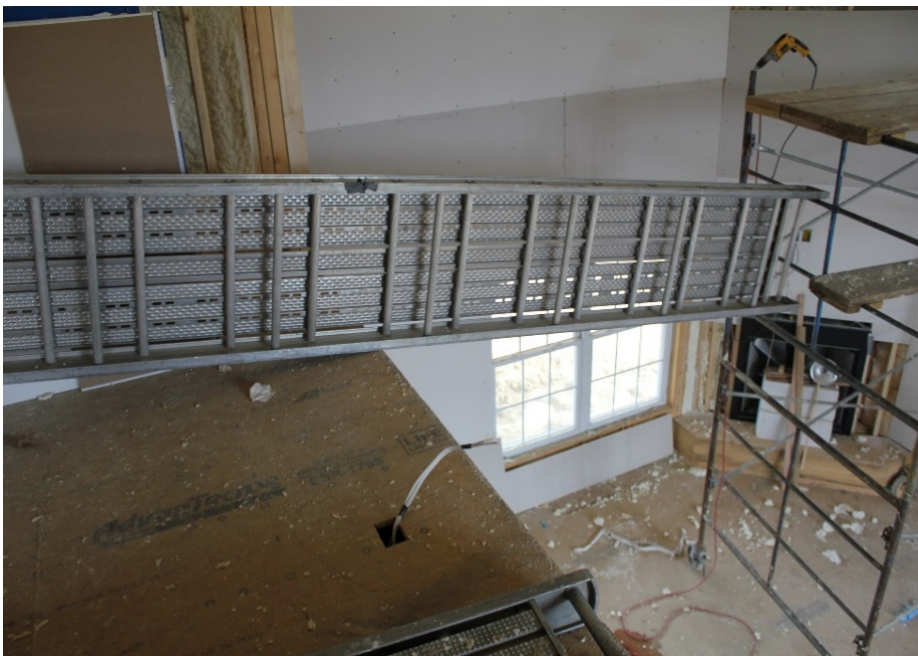
Figure 2. Position of the plank after it had flipped onto its side. Photo taken from loft area

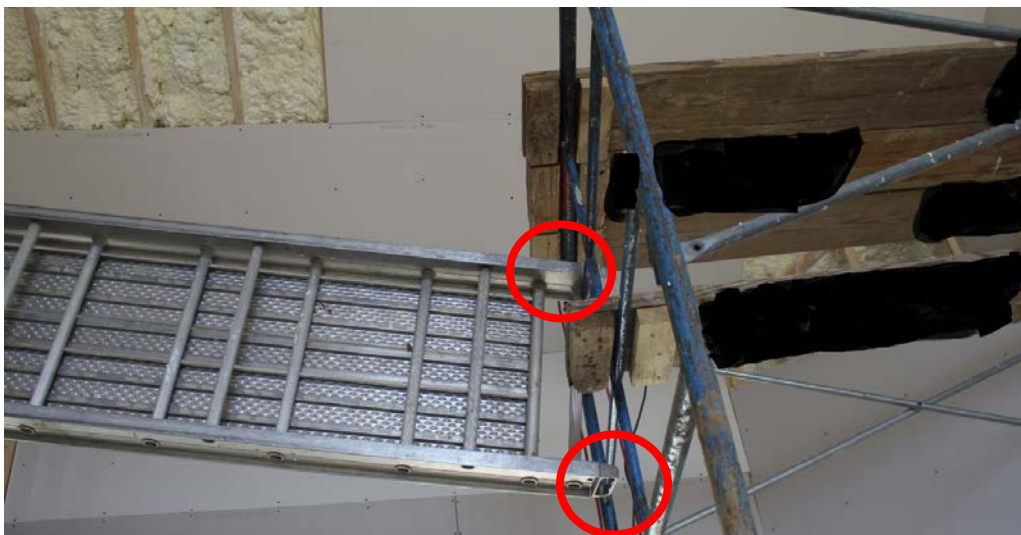
Figure 3. Position of the plank after the accident. Note the lack of attaching hooks (circled)

Before beginning the installation of the guardrails on the scaffolding, the victim stepped onto the unsecured metal walk plank in order to hang a sheet of drywall. When the co-worker was asked why there were no guardrails, he stated there was not enough room because of the angle of the ceiling and the height of the scaffold. As the victim was approximately halfway through installation of the drywall sheet, the metal walk plank flipped on its side throwing the victim head first 10 feet, 9 inches below to the subflooring made up of wood over top of concrete. The victim's coworker immediately contacted emergency medical services and the company. EMS arrived within 12 minutes of the call, but was unable to resuscitate him. The victim was pronounced dead at the scene by the county coroner.

Discussion: The supervisor was using a metal walk plank for the purpose of accessing the elevated loft area via the scaffold. The intended purpose of this particular metal plank was to be used as a stair ramp for moving materials into the house, and was not meant to be used as part of a scaffold. Even if the employee had been using an approved scaffold extension, according to OSHA regulation 29 CFR 1926.452(w)(6)(v)(7)³, *“no employee is on any part of scaffold which extends outward beyond wheels, casters or other supports.”* In order to use platforms that extend outward beyond support, the scaffold must use outrigger frames or equivalent devices to ensure stability.

Recommendation #3: Employers should ensure scaffolds are fully planked or decked.

Recommendation #4: Employees working on scaffolds should always use fall protection in the form of guardrail or personal fall arrest system for each employee 10 or more feet above the lower level.
