REPORT#: 2019-01 REPORT DATE: July 29, 2021

City Electric Maintenance Worker Electrocuted While Installing Lines for Security Cameras – Ohio

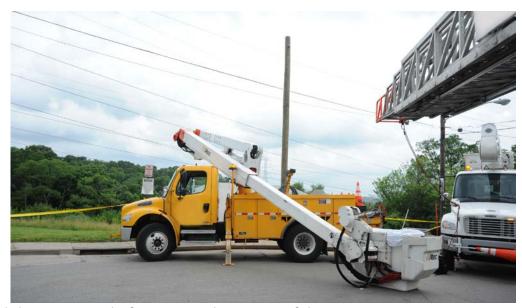
The equipment on-site on the day of the incident was a 2008 Freightliner M2 utility truck mounted with an Altec aerial articulating lift truck and basket rated for 46kV and below with dielectric usage category C (Photo 1). The employer conducted regular routine maintenance of the utility truck and maintained service records. The vehicle mounted lift was inspected on July 7, 2018 and passed an annual dielectric test but failed the annual visual inspection of equipment test including vehicle body, outriggers, controls, boom and bucket. The employer removed the equipment from service, completed the necessary repairs and placed it back in service. At the time of the incident the lift truck was compliant with all annual testing requirements.

Photo 1. Freightliner M2 Aerial Lift Boom Truck Courtesy of the City

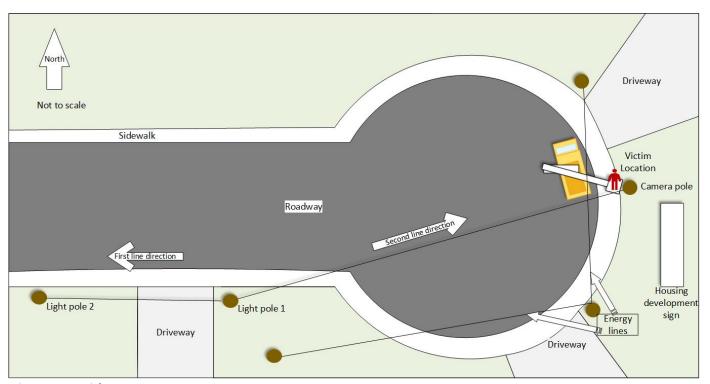
The incident occurred in a residential area at the end of a cul-de-sac (Diagram). The city was in the process of installing surveillance cameras along the cul-de-sac. The cameras were to be attached to the light poles along the street (Photo 2). The light poles were on the South side of the street running East/West. At the end of the cul-de-sac was a housing REPORT#: 2019-01

Diagram. Incident scene

the basket, starting at light pole #1 and working his way up the road to the other light poles that ran from the cul-de-sac area to the main roadway (from East to West) (See Diagram).

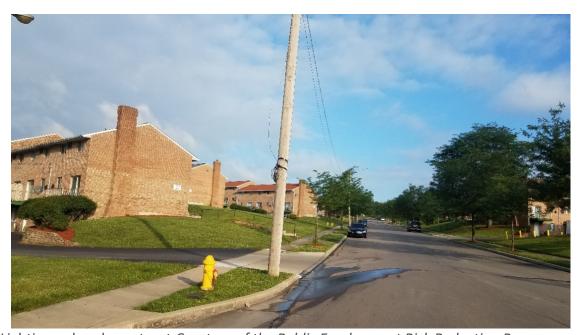
Photo 2. Lighting poles along street Courtesy of the Public Employment Risk Reduction Program

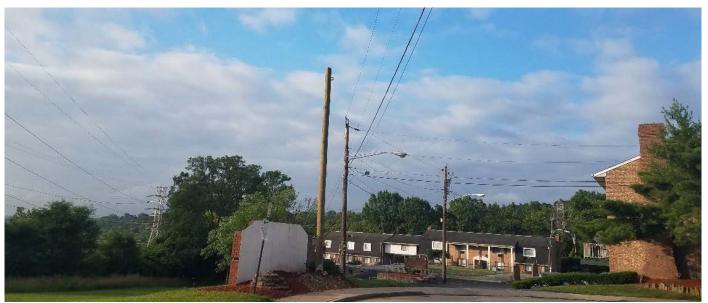
development sign with the housing development driveways on each side of the sign. Above the sign were a series of power lines, cable lines, and phone lines attached to light poles mounted near the development driveways. These utility lines supplied the nearby housing developments. Next to the development sign was a newly placed camera pole where one of the future surveillance cameras would be placed (Photo 3). The electric power lines running to the housing development were 1,300 volt lines, beyond these lines were 3-phase 7,200 volt power lines. The electric maintenance worker was found by firefighters in the raised basket of the bucket truck, which was parked near the new pole under the series of power, cable, and phone lines (Photos 3 and 4).

Photo 3. Photo of new camera pole at end of cul-de-sac *Courtesy of the Public Employment Risk Reduction Program*

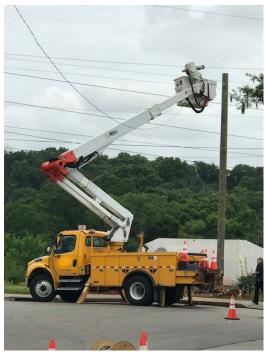
Photo 4. Position of bucket truck in cul-de-sac at the time of the incident *Courtesy of the City*

According to a GPS tracker in the elevated bucket truck, the electric maintenance worker left light pole #1, turned the elevated bucket truck around and drove up the street to position the truck in front of the newly placed security pole. A 1,300 volt power line was located in close proximity to the camera pole. The electric maintenance worker got in the basket and raised it approximately 28 feet. He began pulling some triplex service wire and installing it on the security pole. It is believed he did not realize his proximity to the power lines while performing this task and contacted his right shoulder with the energized power line.

Recommendation #1: Prior to assigning work, employers should determine appropriate safety distances while working near electrical power line hazards.
