**LINE OF DUTY  
DEATH REPORT  
REPORT SLIDES**

## **F2018-13**

**Firefighter Dies after Falling  
Through a Floor at a Large Area  
Residential Structure Fire –  
Maryland**

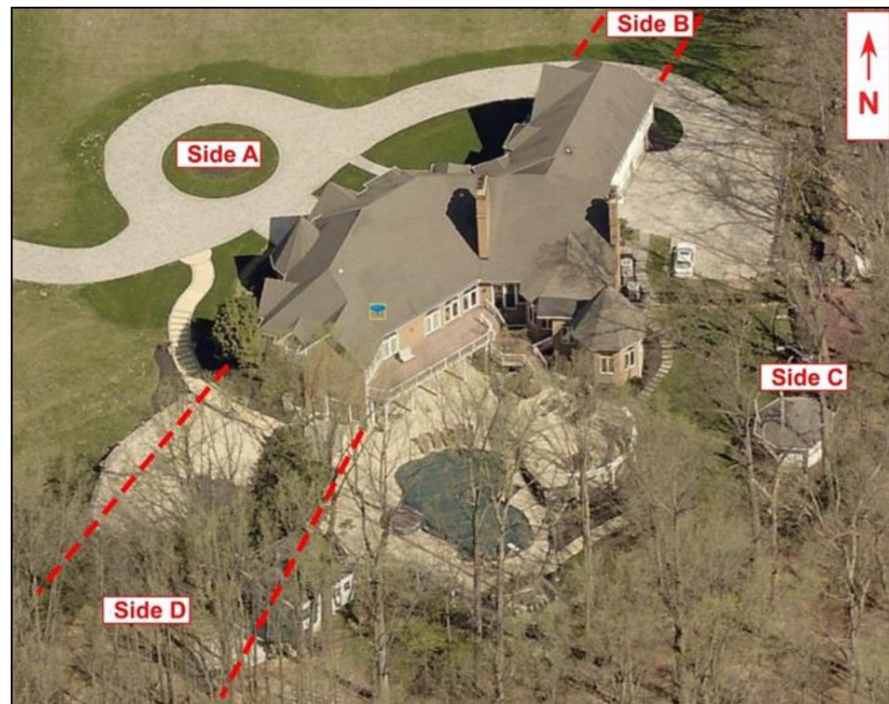
An aerial view of the home showing the sides of the house as defined by the fire & rescue department.. Note that Side Charlie has an upper (1st floor) and lower (below grade) level with a swimming pool.

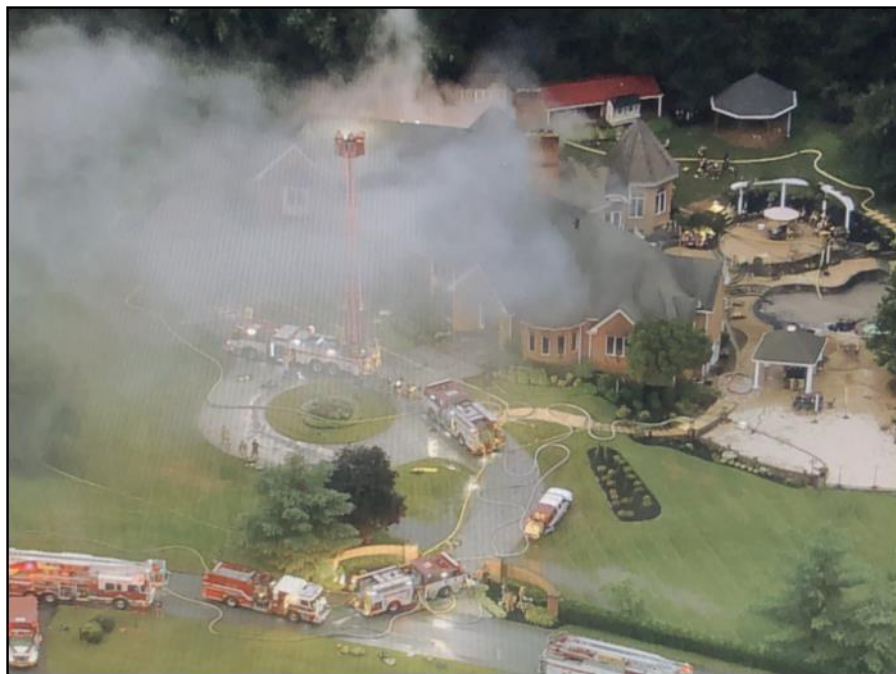
Crews operating in a defensive strategy working to knock down the fire in 8,400 square foot single-family home. Aerial photo taken at approximately 1000 hours.

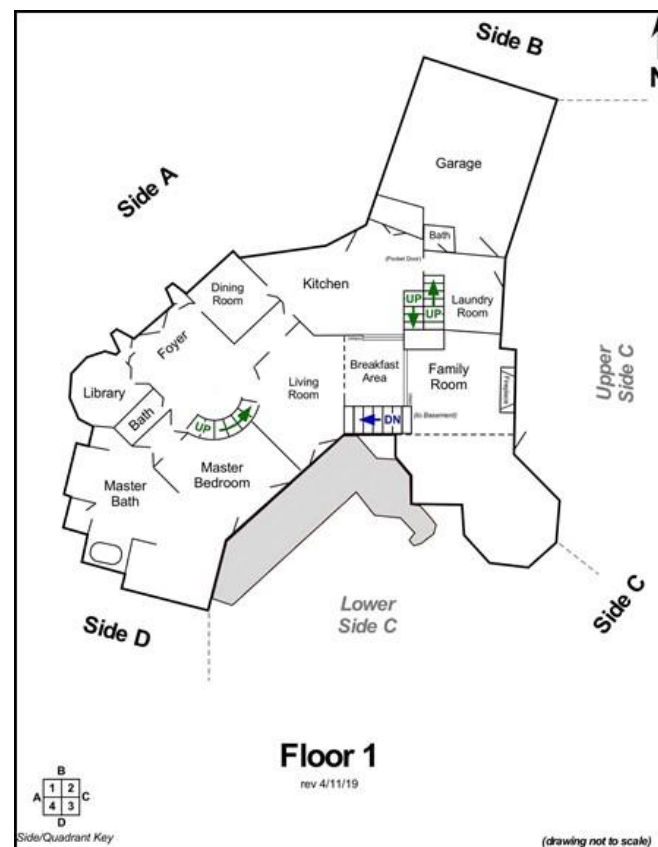
Diagram of the 1st floor.  
(Diagram courtesy of the Fire & Rescue Department.)

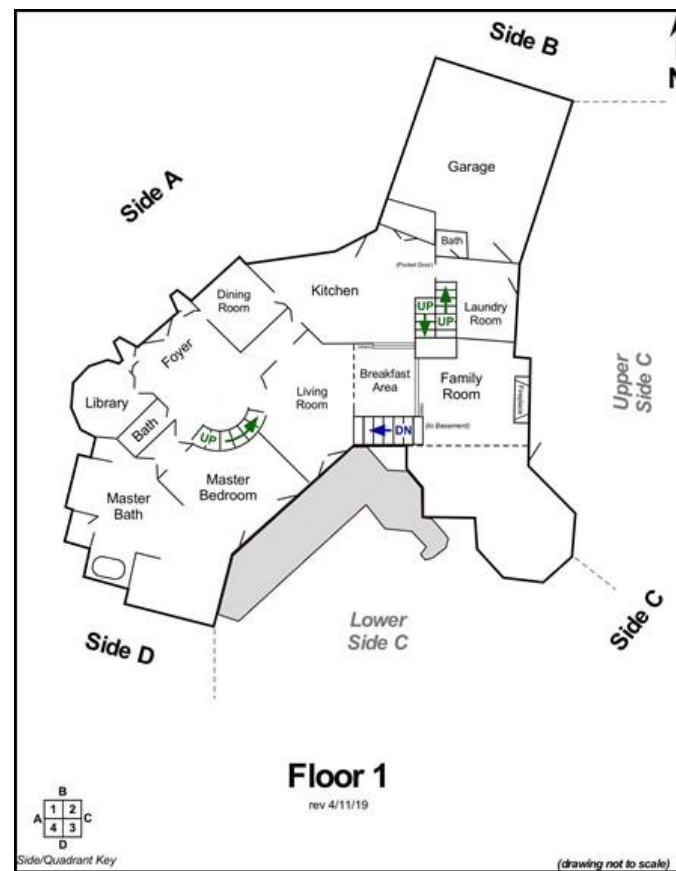
Diagram of the 1st floor.  
(Diagram courtesy of the Fire & Rescue Department.)

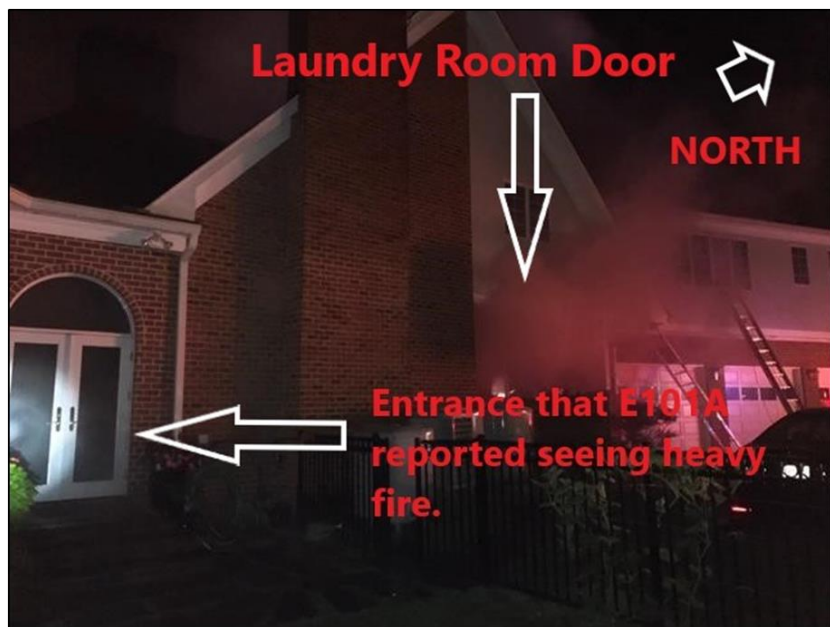
Upper-level Side Charlie. Arrow shows the double doors on the left where E101A reported seeing heavy fire. The doorway with the heavy smoke showing is the entrance to the laundry room. The time is approximately 0215 hours.  
*(Photo courtesy of the Fire & Rescue Department.)*

- 0215 hours – E51A notifies Command that the fire attack crew has smoke in the basement but cannot find the fire.
- 0216 hours – E101A notifies Command that there is heavy fire on the first floor Side Charlie (see arrow in photograph). E101A orders E101B out of the baseline and they begin to pull a 200-foot 1 ¾-inch hoseline from E51 to the laundry room door.
- 0217 hours – Command is confused about where the attack group is entering the structure. TWR10A clarifies that E101 and E51 are entering the 1<sup>st</sup> floor on Side Charlie and the basement still has floor to ceiling smoke. The attack crew exited the basement, closed the door, and headed to the laundry room door on the upper level of Side Charlie.

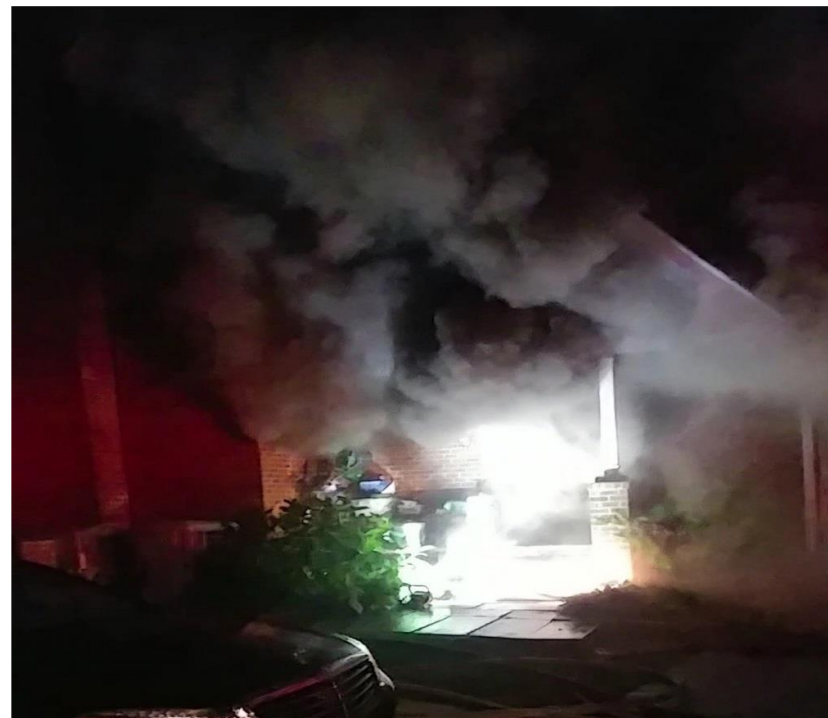
Heavy black smoke pouring out of the 1<sup>st</sup> floor laundry room door during RIC operations.  
(Photo courtesy of the Fire & Rescue Department.)

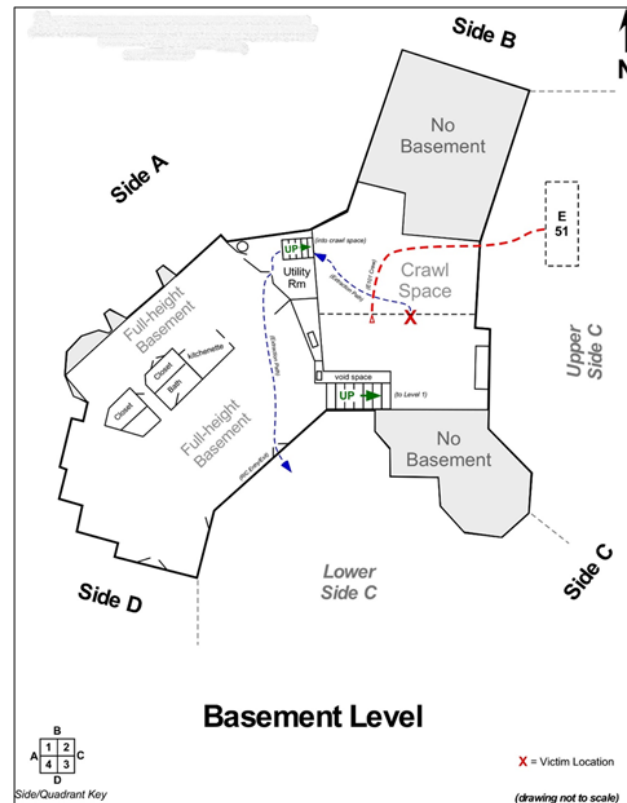
- 0220 hours - E71 and P56 join T7 on the rapid intervention group and re-position to Side Charlie.
- ~0228 hours – The rapid intervention group enters the basement with 300-foot 1 3/4-inch hoseline. “Cold smoke” conditions with poor visibility. Right-handed search used.
- ~0230 hours - The rapid intervention group encountered a second set of steps in the utility room leading into to the crawlspace with high heat and visible fire. The rapid intervention group moved in the direction of E101B’s alarming PASS device. Wires, and storage items impede progress. E71C reaches E101B who is unconscious. The rapid intervention group pulls/passes E101B along the extraction route (blue dotted line in the diagram).

Sketch of the basement. The red “X” marks the approximate location where E101B was found. Blue dotted line is the extraction pathway. The red dotted line is the hoseline used by E101B on the 1<sup>st</sup> floor.

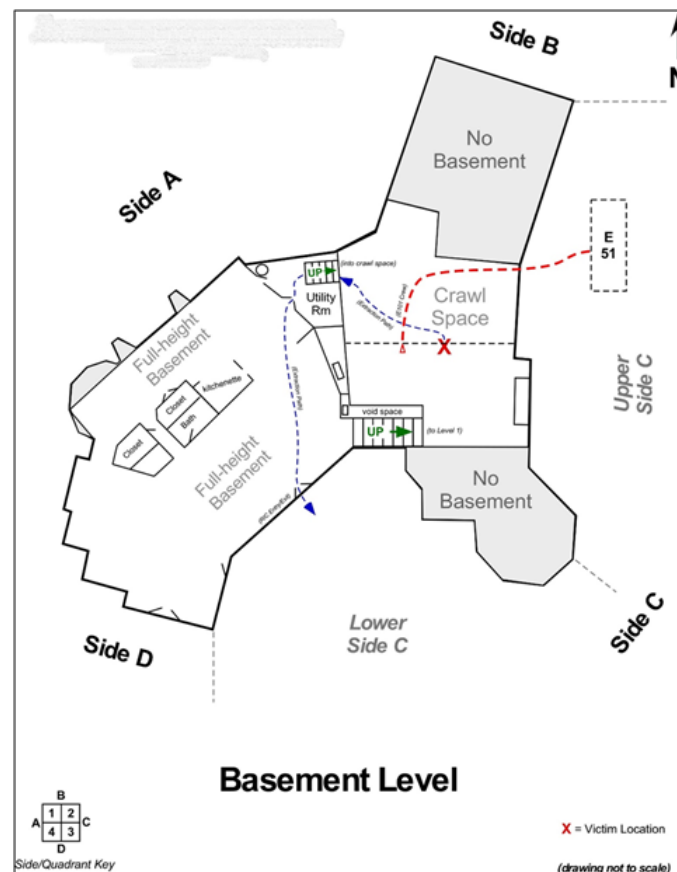
Sketch of the basement. The red "X" marks the approximate location where E101B was found. Blue dotted line is the extraction pathway. The red dotted line is the hoseline used by E101B on the 1<sup>st</sup> floor.  
(Diagram courtesy of the Fire & Rescue Department.)
