Coffee Stand Owner Dies When Leak from Propane Cylinder Causes a Fire

Investigation: # 16WA00101

Release Date: October 20, 2016

SHARP Report: # 52-37-2016

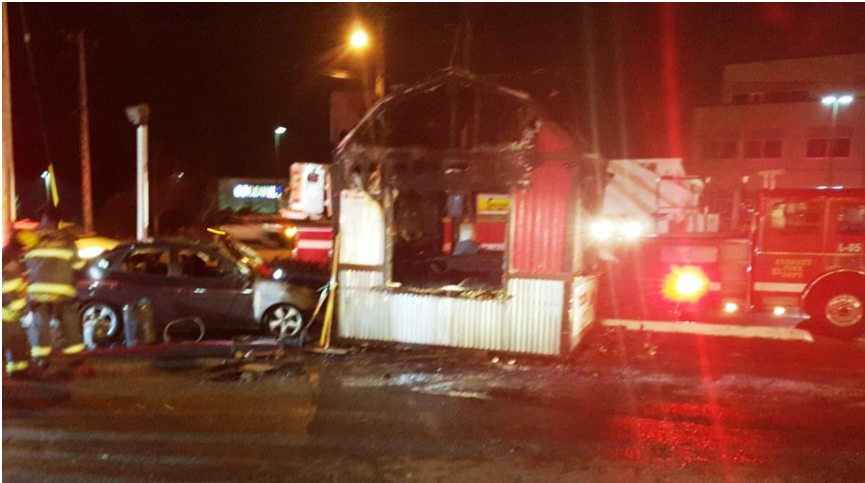
Photo 1: The coffee stand after fire department personnel had extinguished the fire.

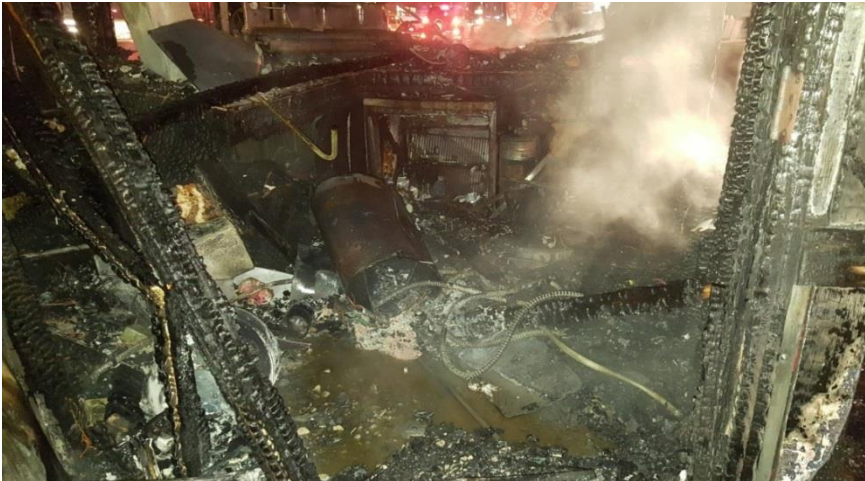
Photo 2: The coffee stand interior after the fire.

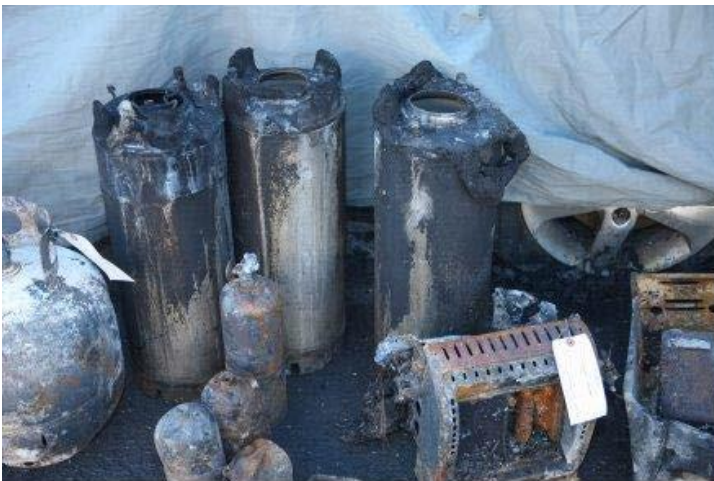
Photo 3: Incident propane cylinders and space heater.

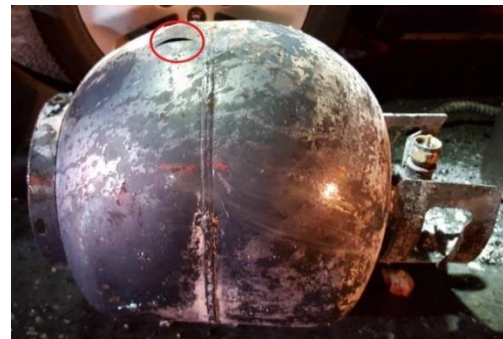
An investigation by the city fire department found that the ignition source of the fire was the open flame of the space heater pilot light that ignited an uncontrolled release of propane vapor from the 20-pound propane cylinder that was located inside the stand.

Photo 4: Incident 20-lb. propane cylinder as found inside the stand. A cylinder breach crack was caused by the fire (circled).

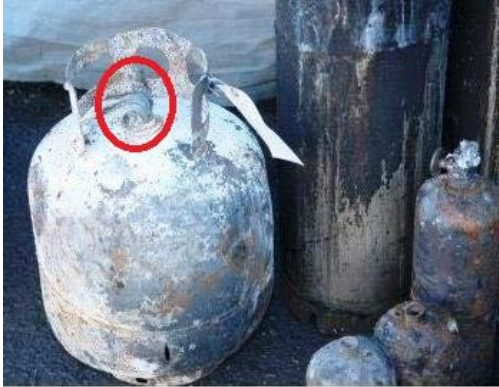
Photo 5: Incident 20 lb. propane cylinder with threaded adapter attachment in valve orifice.

Discussion: The explosion and fire occurred while the victim was using a propane adapter to transfer propane from a 20-pound cylinder to 1-pound cylinders. Fire investigators determined that a leak from the 20-pound cylinder was the source of propane vapor that was ignited by the space heater's pilot flame, thereby causing a flash fire. It is unknown why the leak occurred. It is possible that the adapter was improperly secured to the 20-pound cylinder's valve, thereby causing propane leakage. Or there may have been damage to the 20-pound cylinder's valve, or some other factor that caused the leak. The condition of the 20-pound cylinder prior to the incident is unknown. What is known is that the cylinder was manufactured before September 30, 1998. This is the date by which the National Fire Protection Association (NFPA) guidelines, as specified in NFPA 58 Liquefied Petroleum Gas Code, required propane cylinders with a 4 to 40-pound capacity to be manufactured with an Overfilling Prevention Device (OPD). Washington State adopted this requirement in 2002. There is no federal requirement to have an OPD. The 20-pound cylinder in this incident did not have an OPD. This indicates that the cylinder may not have been properly maintained if the OPD was not installed when it was refilled.

Recommendation #2: Employers and business owners should not use adapters to transfer propane from larger cylinders to refill one-time use only 1-pound propane cylinders, as this practice creates a risk of fire, explosion, serious injury, or death.

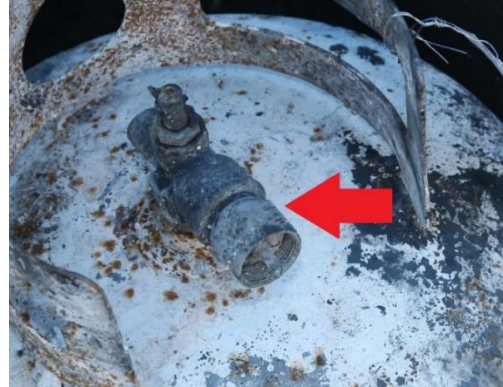
Photo 6: Close-up of the adapter.

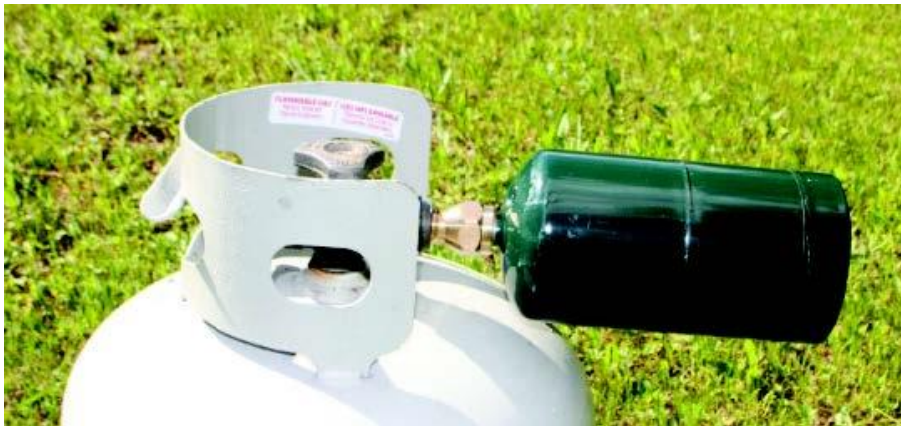
Photo 7: Non-reusable DOT 39 propane cylinder on the right attached by an adapter to a larger propane cylinder. This configuration is similar to that of the incident cylinders and adapter.

Though not a factor in this incident, because the 1-pound cylinders are manufactured for one-time only use and are not subject to the more rigorous manufacturing standards of refillable cylinders, they may present a safety hazard if refilled and reused. Over time, with the stresses of multiple refills and emptying, these cylinders may become less durable and potentially subject to failure, presenting a risk of fire, explosion, serious injury, and death.

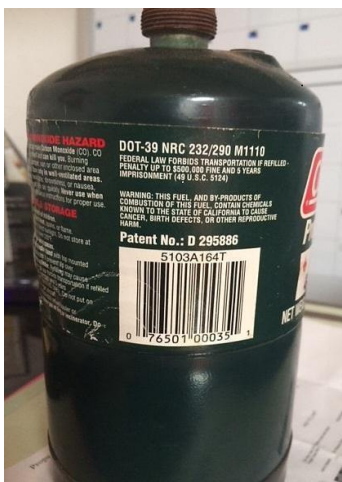
Photo 9: Standard warning label on 1-pound DOT 39 propane cylinder with message: "FEDERAL LAW FORBIDS TRANSPORTATION IF REFILLED – PENALTY UP TO \$500,00 FINE AND FIVE YEARS' IMPRISONMENT (49 U.S.C. 5124)"

Additionally, Federal law forbids the transportation of these 1-pound cylinders, also known as DOT 39 cylinders, if they are refilled. Washington State law does not allow the refilling or reuse of containers manufactured in accordance with the specifications of 49 CFR Part 178 and authorized by 49 CFR Chapter 1 as a “single trip” or “nonrefillable container” in LP (Liquefied Petroleum) gas service.

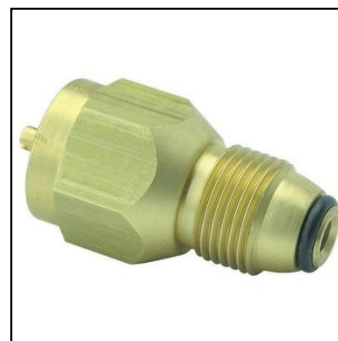
Photo 8: Adapter example.
