GROUND CONTROL FOR HIGHWALL MINING

BY R. KARL ZIPF, JR. AND CHRISTOPHER MARK

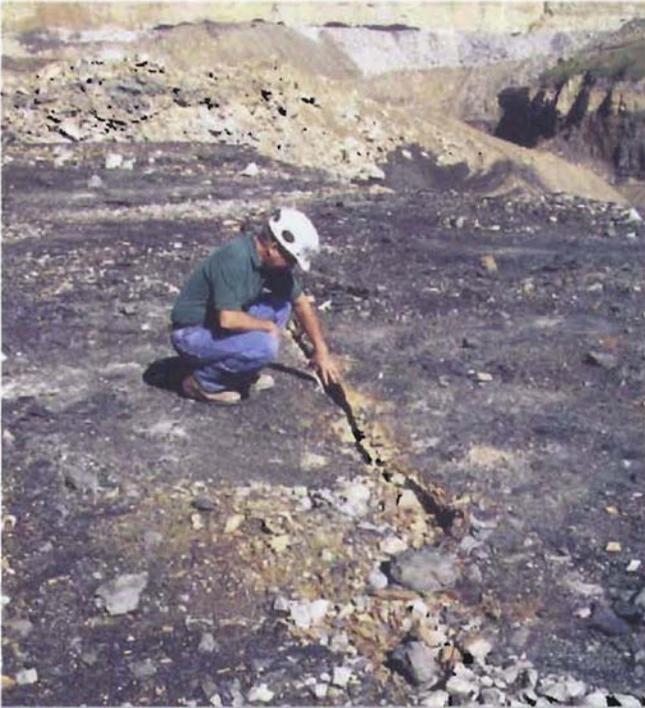
Figure 3-Crack in bench above highwall mining operation.

Inspection and monitoring—Daily inspection of the benches above the active highwall mining area is a prudent precautionary measure. A crack in a bench immediately above a highwall miner is shown in Figure 3. Simple displacement monitors may be useful for detecting movement along cracks that may precede a significant life-threatening failure. New tools, such as slope monitoring radar, may also prove useful in detecting motion of the rock slopes above active highwall mining operations.

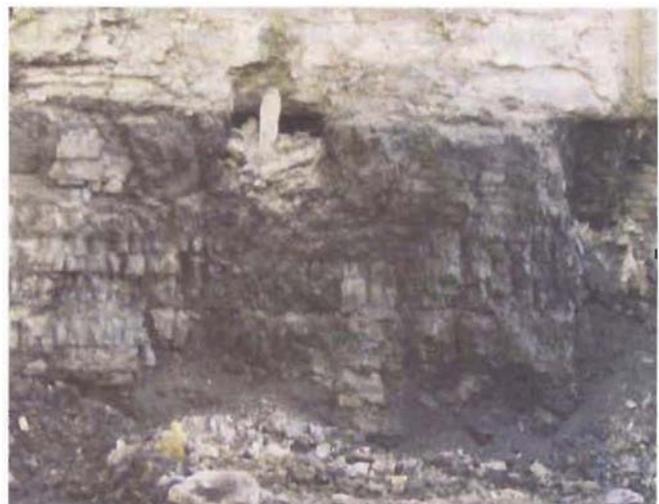
Figure 7- Old underground works daylighting in highwall can pose ground control hazards.

Highwall stability issues are often most severe near "ridge points." Most operators protect themselves by leaving a substantial safety barrier in which no mining is conducted near ridge points (See Figure 5). The wall rock is also often fractured in the heads of the hollows beneath stream valleys, and these areas should also be avoided (See Figure 6). Many other features, including old underground works that daylight in the highwall (See Figure 7), can also be hazardous.

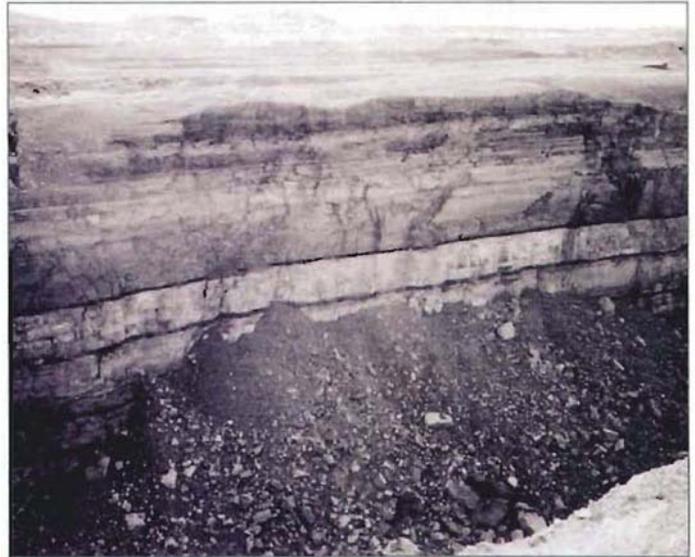
Figure 8-Site of massive web pillar collapse resulting in highwall slope failure. Photograph was taken from adjacent spoil pile. Highwall is about 150 ft high. A 110-ton coal haulage truck is buried in rockfall debris.

MSHA recognizes the ground-control-related safety concerns associated with highwall mining and requires each highwall mining operation to develop and follow 'an appropriate highwall ground control plan, which addresses the web spacing and other measures necessary to safely conduct the high rates of recovery.' Proper pillar design is essential to maintain highwall stability and to prevent entrapments. The results of one large pillar failure is shown in Figure 8. In this case, 30 to 50 web pillars failed suddenly, which caused substantial rock fall from the highwall. The rock fall was sufficient to completely bury a 110-ton haul truck. Fortunately no one was in the pit when this failure occurred. Another area where web pillar failure led to large rockfalls from the highwall is shown in Figure 9. The web pillar collapse also trapped the highwall miner which required several months' effort to recover.

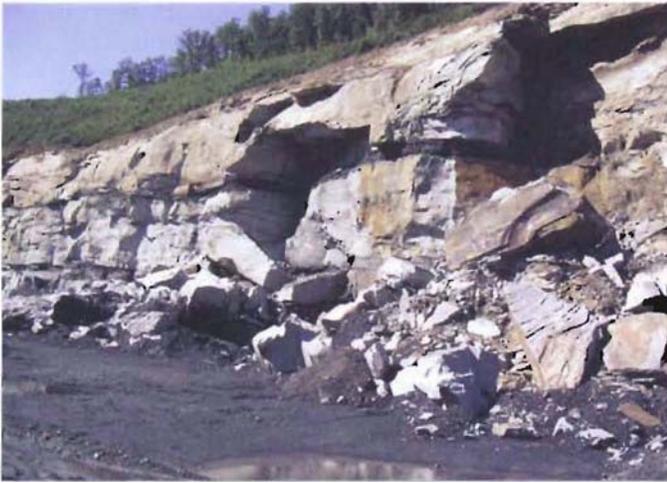
Figure 9—Highwall collapse site.

Multiple seam mining becomes most problematic **when** the interburden thickness **between** seams decreases to less than about one highwall miner hole width (10 to 12 ft). In one instance, the lower seam split was mined first, followed by partial backfilling of the pit and mining of the upper seam split. A weak, laminated interburden ranging in thickness from 4 to 10 ft separated the two **splits**. Catastrophic collapse (or domino failure) of the web pillars occurred **that** resulted in **this** extensive highwall failure.

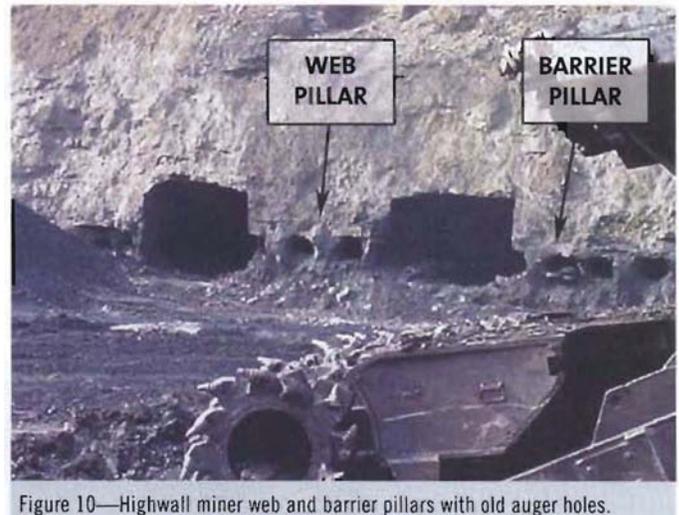
Figure 10—Highwall miner web and barrier pillars with old auger holes.

At least 20% of the highwall mining operations expect to encounter old auger holes somewhere on the property, according to a recent analysis of MSHA highwall mining ground control plans. A typical highwall mining web and barrier pillars containing pre-existing auger holes is shown in Figure 10. Although these auger holes may only penetrate the highwall 100 ft or so, they substantially weaken the web pillars directly beneath the highwall. Conventional coal

NIOSH researchers used numerical models to estimate the strength of highwall mining web pillars containing pre-existing auger holes. These calculations for a range of practical auger mining geometries indicate that the strength of a highwall mining web pillar containing auger holes is 25% to as little as 15% of the solid web pillar strength.
