**Decontamination of Building Materials Contaminated with
Methamphetamine**

John W. Martyny, Ph.D., CIH
Associate Professor
National Jewish Medical and Research Center
Division of Environmental and Occupational Health Sciences

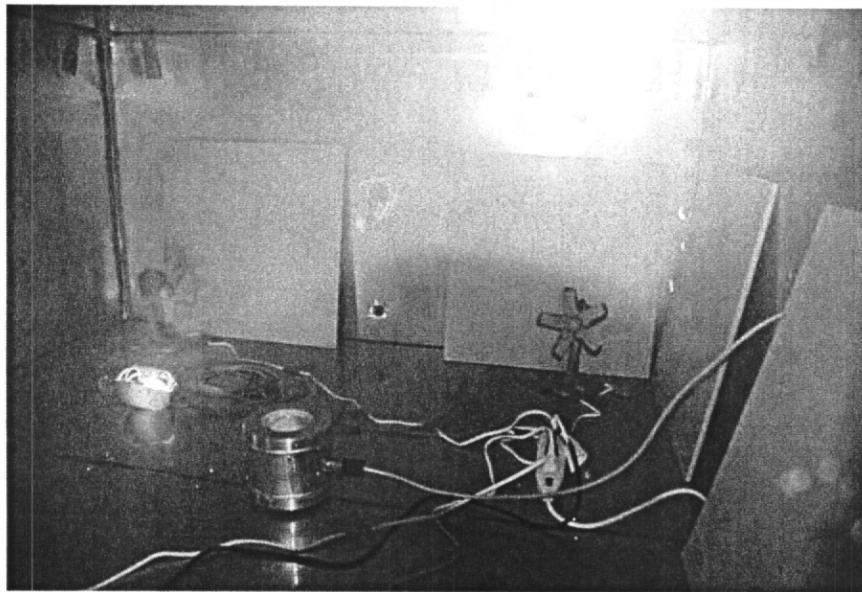
Figure 2. Painted drywall material being contaminated within the chamber.

After painting, the plywood panels, the drywall panels, the metal and the glass panels were put into the chamber for contamination. Each of the materials were put into the chamber at different times and using different amounts of methamphetamine (although all were approximately 200 mg). The contamination information is as follows:

The methamphetamine utilized for contamination was a street-manufactured methamphetamine provided by the North Metro Task Force in Colorado. The drug was approximately 77% methamphetamine and also contained small amounts of amphetamine, ephedrine, and pseudophedrine. No MDMA or phenylpropanolamine were found to be present. The methamphetamine was put into a beaker and the chamber was sealed and the methamphetamine aerosolized in the chamber. The methamphetamine was completely aerosolized within a short time (listed above) and the beaker heater was turned off. The fans within the chamber were kept running for another period of time to assure even distribution of the methamphetamine. The chamber was then allowed to sit overnight and the material was removed the next day.
