EFFECTIVE DATE	REVISION NUMBER	DESCRIPTION
01/10/2004	00	New Technical Basis Document for the Rocky Flats Plant – Site Description. First approved issue. Initiated by Robert Meyer.
02/01/2007	01	Approved Revision 01 revised in response to formal OCAS and ORAU comments. Includes additional incidents and occurrences post-1981. This revision addresses Worker Outreach comments as described in CT-0200 and CT-0204, in Section 2.4.5. Revised to consider attribution per ORAU direction and to respond to Union member comments. Incorporates NIOSH formal review comments. No further changes occurred as a result of formal internal review. Constitutes a total rewrite of document. Training required: As determined by the Task Manager. Initiated by Robert Meyer.
08/20/2020	02	Revision initiated to address Advisory Board comments and items associated with SEC-00192. Incorporates formal internal review and NIOSH review comments. Constitutes a total rewrite of the document. Training required: As determined by the Objective Manager. Initiated by Mutty Sharfi.

2.2.1 History and Mission

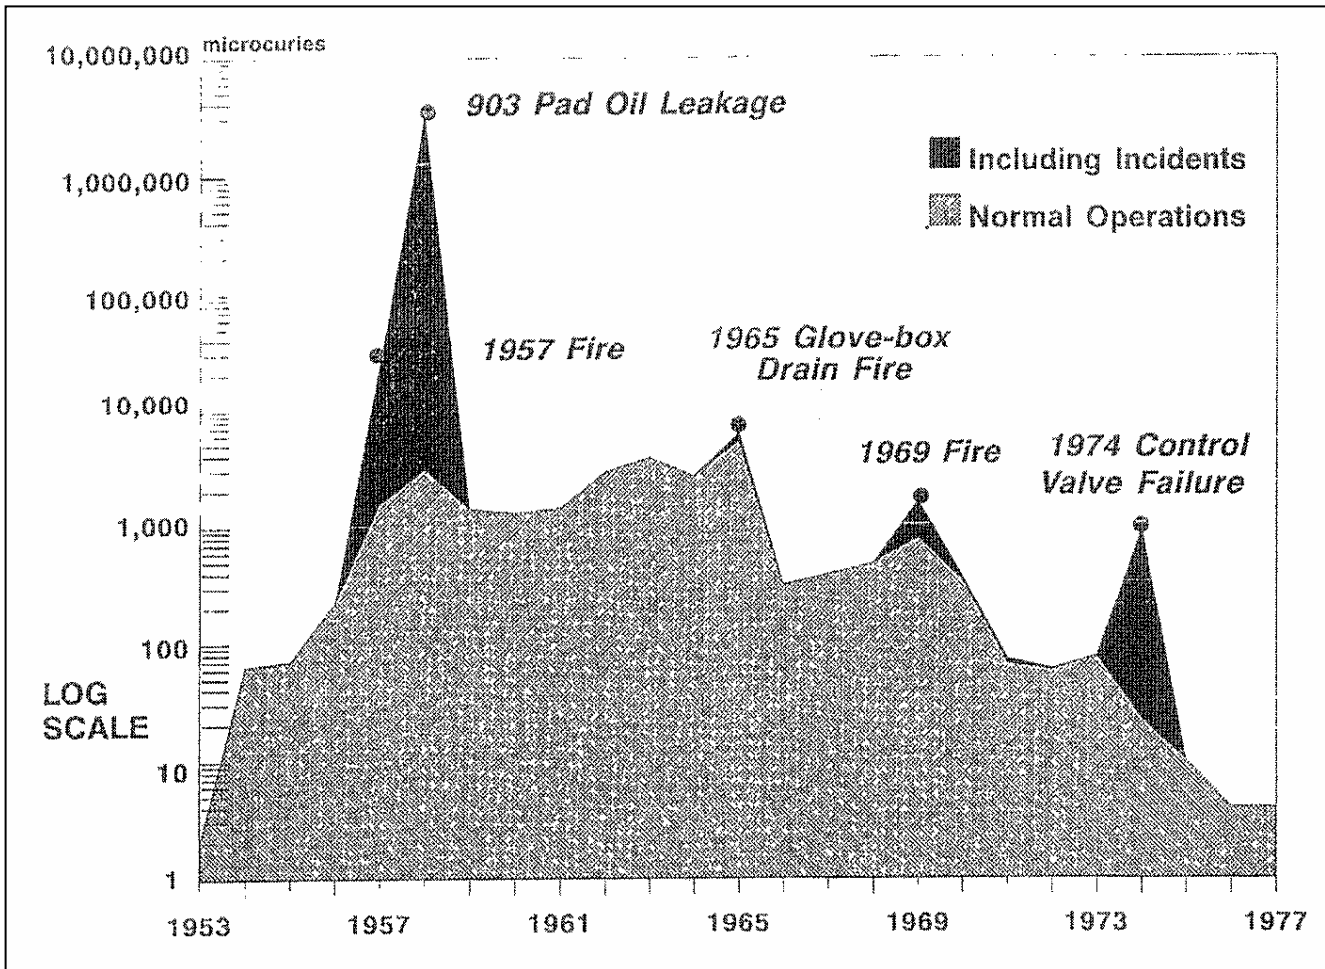
Figure 2-6. Reported gross alpha radioactivity emissions from plutonium facilities (ChemRisk 1992, p. 227).

Figure 2-6 shows gross alpha releases to the environment from 1953 to 1977.
