Evaluation of Occupational Exposures and Indoor Environmental Quality in an Underground Cavern Workplace

HHE Report No. 2018-0181-3389

August 2023

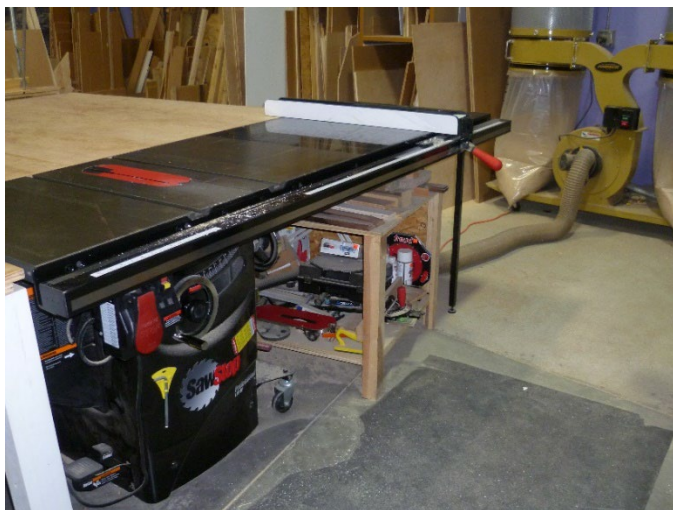
On the day of air monitoring, the employee in the painting area did a limited amount of sanding using a handheld sander. The employee in the woodshop used the table saw, compound miter saw, and handheld router to cut and prepare various sized boards for building crates and other wood items. The wood was primarily pine. The table saw was connected to a Powermatic company dust collection system (Figure B1). The miter saw was connected to a mobile dust extractor built by the miter saw manufacturer, Festool (Figure B2). Because the router was also manufactured by Festool, this mobile dust extractor was disconnected from the miter saw and also used for the router. The company planned to purchase a separate mobile dust extractor for the handheld router.

Figure B1. Woodshop table saw with exhaust duct connected to the dust collector. Photo by NIOSH.

- Install an exhaust hood over the top of the saw blade to better contain and exhaust the wood dust as it is thrown from the blade. The manufacturer of the table saw in the woodshop has an overarm dust collector available for use with that table saw.
- Rotate the table saw 90 degrees to allow the saw to be connected to the dust collector with a straight length of exhaust duct. This will reduce the total length of duct needed and eliminate a greater than 90-degree bend at its point of attachment to the table.
- Replace the corrugated plastic duct with rigid smooth interior duct.

Although the handheld router, miter, and table saw were connected to dust collection systems, improving dust capture efficiency of these dust collectors could increase their effectiveness and reduce wood dust exposures. The dust extractor suction power settings should be adjusted to adequately capture dust at the saw. Because the miter saw was permanently affixed to the worktable, replacing the lengthy plastic exhaust hose connecting the miter saw and extractor with a shorter length of exhaust hose could reduce air resistance within the hose and increase exhaust efficiency.

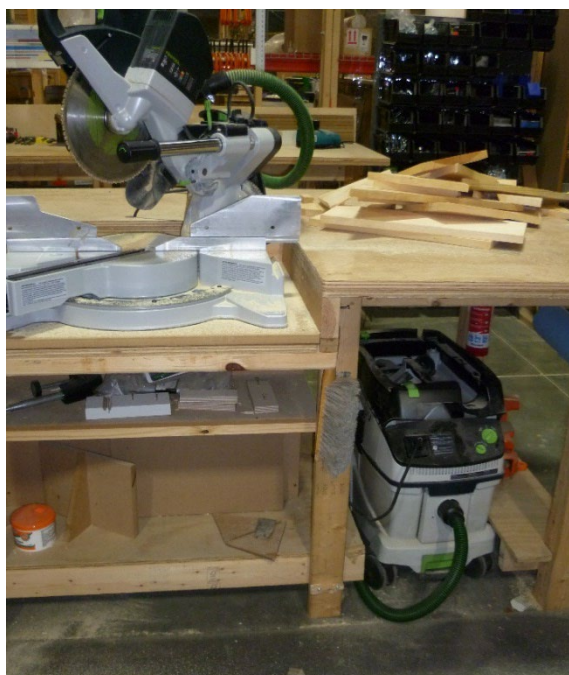
Figure B2. Compound miter saw connected to a mobile dust extractor. Photo by NIOSH.

- Ensure that the dust extractor suction power settings are adjusted to fully capture dust at the saw.
- Replace the lengthy plastic exhaust hose connecting the miter saw and extractor with a shorter length of exhaust hose.

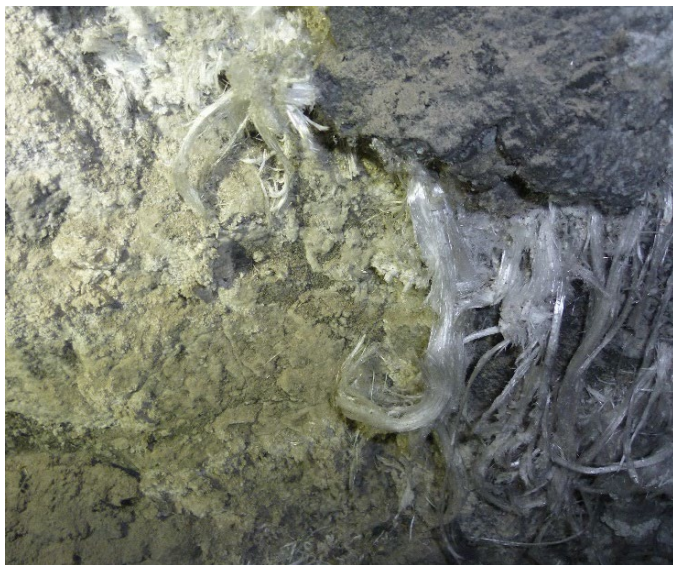
Figure B5 shows the white-colored translucent fibers on a wall of the cavern. Facility staff referred to the fibers as “cave cotton” due to the texture and appearance of the fibers. The analytical laboratory reported that the bulk minerals were white/transparent fibers that were readily soluble in water. The SEM images show typical structures of fibers with diameters in the range of 3 to 30 μm (Figure B6). Elemental analysis showed the presence of magnesium, sulfur, and oxygen in the fibers. The proportional average calculated atomic weight concentrations for the four different samples analyzed were oxygen (61.3), magnesium (19.5), and sulfur (19.2). The atomic weight concentrations suggest that

the mineral fiber contained a compound consisting of magnesium sulfate with formula $MgSO_4$, referred to as epsomite.

Figure B5. Mineral fibers on cavern surface. Photo by NIOSH.

Because the warehouse has relatively limited amounts of these fibers present on the cavern walls, and typical workplace conditions would not cause fibers to become airborne, the fibers should not present a risk to employees. However, if fibers needed to be removed from the wall, use a high efficiency particulate air (HEPA)-filtered vacuum for removal tasks.
